# THE LAST FLIGHT OF LAWRENCE B. SPERRY

by Victor N. Smith

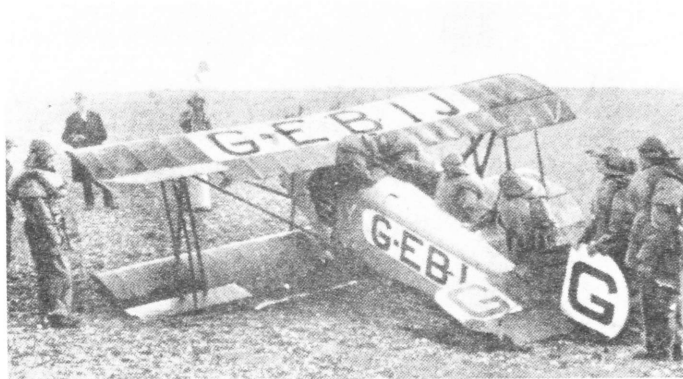
"... it was found that except for a slight buckling of the top starboard wingtip and the tail unit, which occurred during salvage operations, the aeroplane was intact. It had alighted on the water without structural damage. All controls were in working order. A tappet rod and sparking plug wire were accidentally pulled off the starboard cylinder of the engine after the accident.

The Sperry Messenger beached after the accident. Full British markings are seen, including the national G on both the rudder and horizontal tail surfaces. The photographer has dressed a group of local workmen in the lifeboatmen's oilskins and life jackets.  
(Photopress, via the author)
