## *TWA Fokker F-10A Crash Response*

by Mauno Salo

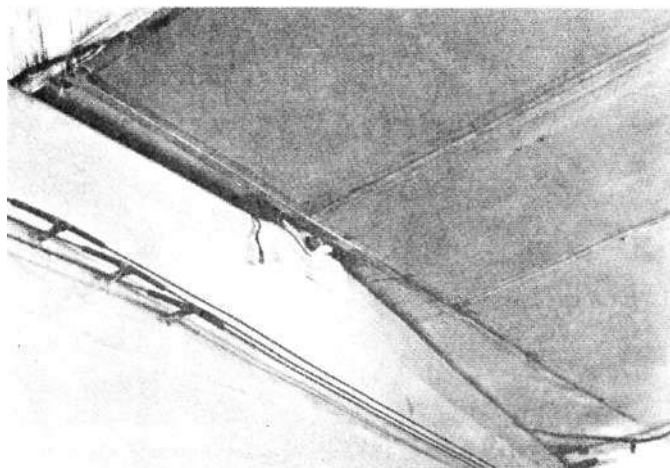
③

- (1) USMC Atlantic-Fokker AF-10 (RA-4 #A-8841) as of Jan. 13, 1931, just seven weeks before the TWA crash. This marine F-10 was relatively new at that time and according to Bill Larkins, had the nose lengthened later by 18" and rudder/fin modified to improve stability. Control cables were enclosed within structure. (NAAF 0118)
- (2) Earlier model (TA-1-2?) with underwing separations of plywood covering near fuselage attachment, 2-12-30. Drain holes visible and outside control cables. (NAAF 0042)
- (3) Starboard underwing. This is where the TWA F-10A wing came off the aircraft, 2-12-30. (NAAF 0043)
- (4) Topside view showing broken stringers of a Marine TA-1, 2-12-30. (NAAF 0044)
