# The Mystery of the Stuck Tail

by Jim Tuttle

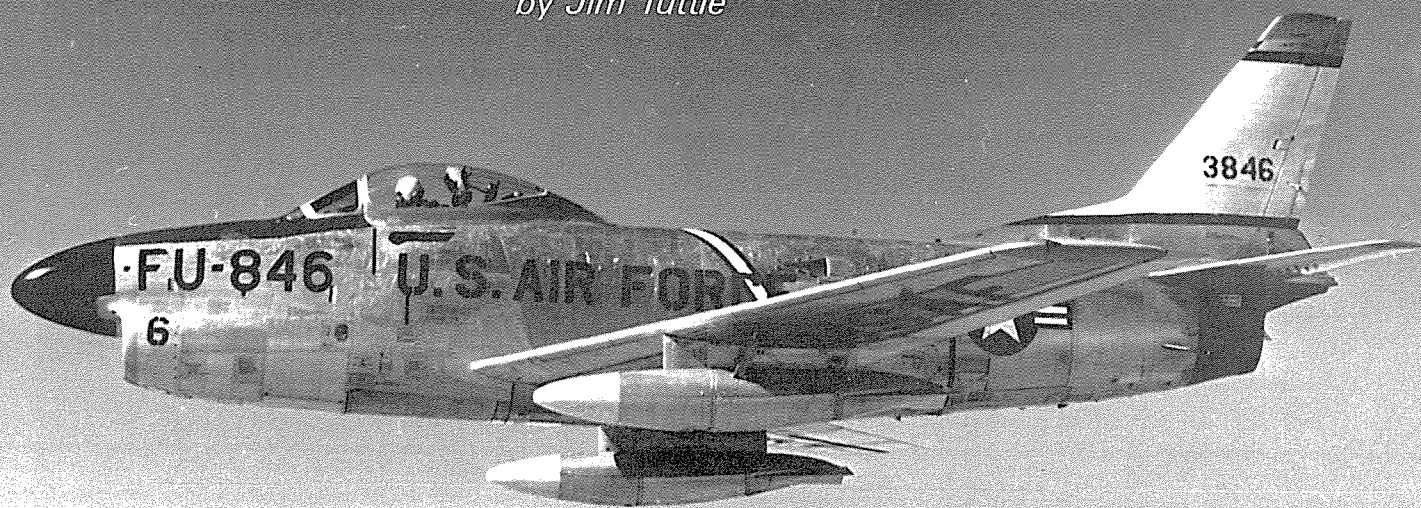
The F-86D was the interceptor version of the F-86 *Sabre* series. In this photo of a late model "D" it is carrying two 120-gallon drop tanks. The bulge just above the jet engine exhaust held the drag chute and directly above that is the rudder that gave North American's engineering department such a difficult time. The rudder section, just above and to the right of the "6" on the tail number is the rudder balance weight, extending inside the vertical stabilizer.

All F-86 aircraft had balance weights on their nonpowered rudder which extended inside the vertical stabilizer as shown in the photo. This balance weight consisted of a hollow aluminum casting, with a hole on top and bottom. During final assembly, the rudder was laid on its side and lead was poured into the hollow casting until a balance condition was achieved. To minimize aerodynamic drag, the clearances between the vertical stabilizer and the rudder balance weight was very small.

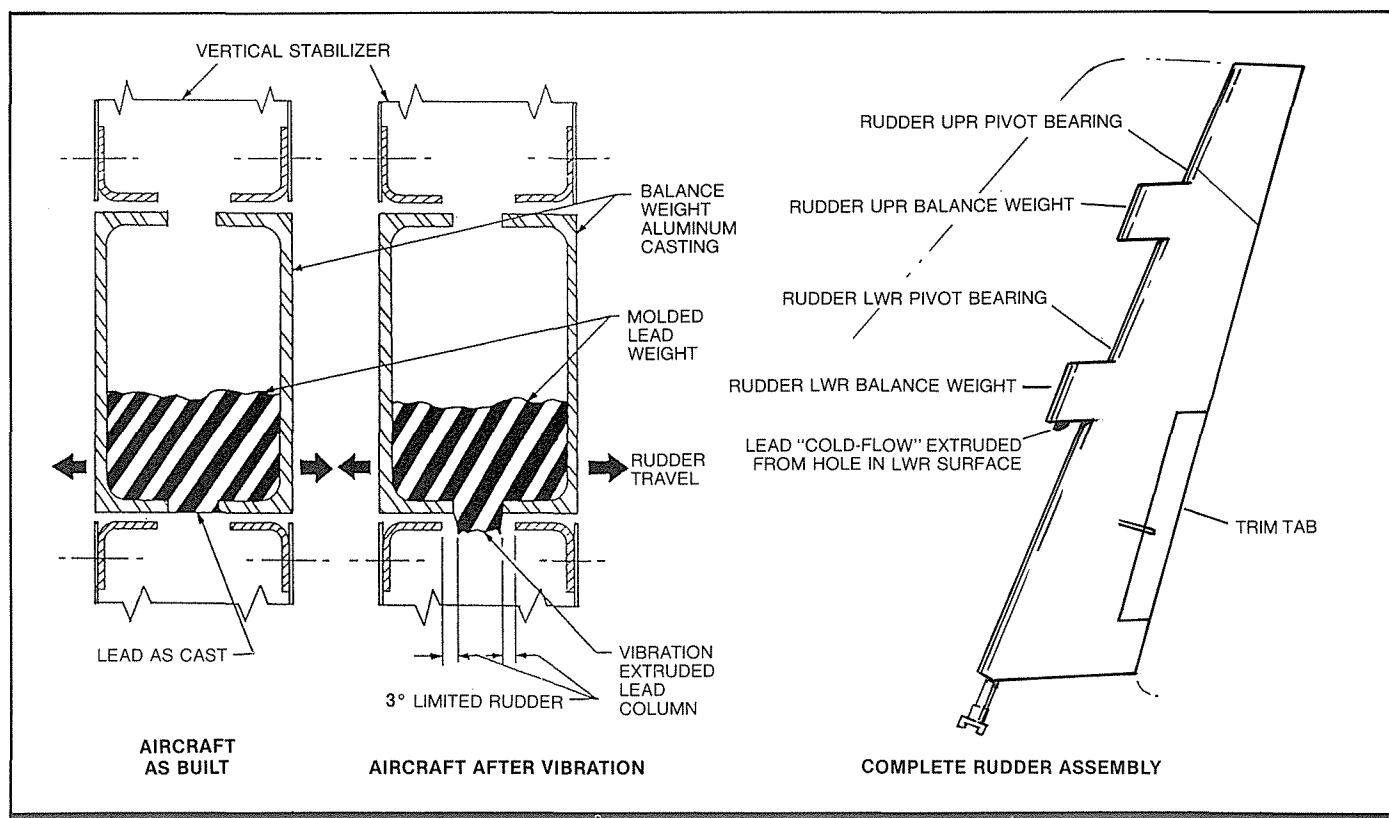
In the case of the F-86D, the additional vibration from the afterburning engine caused the lead to extrude out the bottom hole of the balance weight at a very slow rate. This continued until the lead column which was formed was captured inside the vertical stabilizer as shown in the figure. As lead is relatively soft, the pilots could shear off this column by heavy pressure on the rudder pedals. This immediately cured the rudder limiting, and as the sheared-off column fell clear of the aircraft, all evidence of the problem disappeared.

The reason for the random type failures was that it depended upon: 1) how much clearance existed between the balance weight and vertical stabilizer on a given ship; 2) how much lead was contained in the balance weight; 3) how often and how long the afterburner was used; and finally 4) the air temperature at the time the afterburner was used. The reason the problem was never seen while the autopilot was engaged was that the autopilot inputs were mild and never exceeded the three-degree limited-rudder travel.

The fix was simple, close over the lower balance weight hole with an aluminum plate. Thus, one concerned, dedicated pilot took the precise action necessary to allow an engineering department to solve a mystery that had thus far eluded them.
