# THE LAST FORMAL ACT

by Jay Miller

Underscoring this lack of technological maturity more than any other *Hustler* accident was the loss of the fifth B-58A, AF serial number 55-664, on November 7, 1959, in the skies over

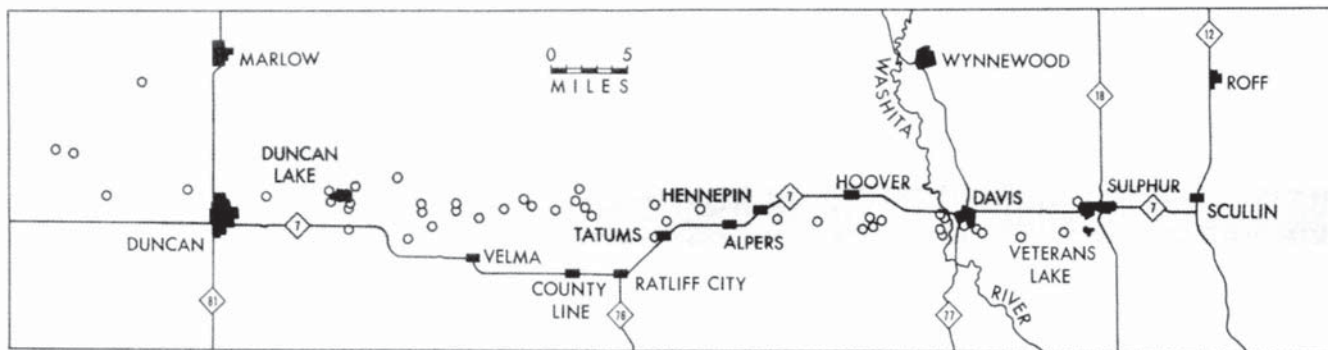
4: The debris footprint over Duncan, Oklahoma, following the loss of '5664 on November 7, 1959. Small circles indicate landing spots of larger debris chunks. Footprint was some 75 miles long. (Photo from General Dynamics)

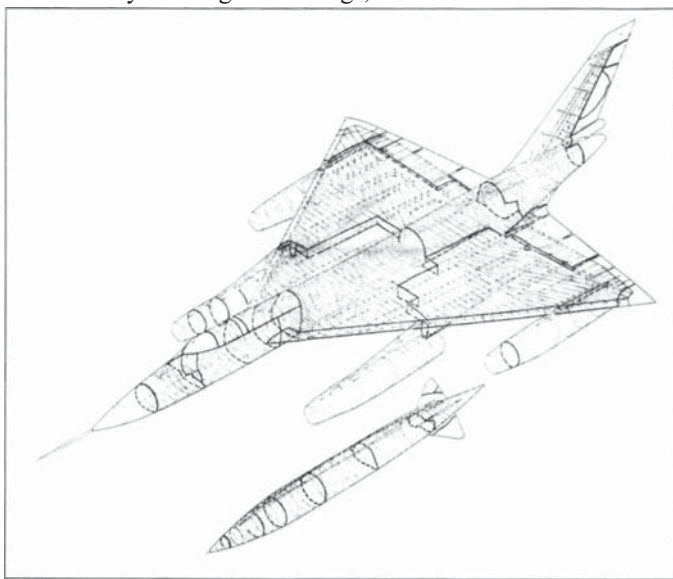
5: B-58 (w/MB-1 pod) internal structure drawing. Dark lines indicate most significant points of separation when '5664 disintegrated. (Photo from General Dynamics)

By now, the vertical tail aerodynamic loads, later estimated to be in excess of forty tons, had exceeded their maximum sustainable limits. The skins and longerons between fuselage stations 13.0 and 15.0 began to buckle...and then fracture. As they failed, the entire vertical tail began a rapid separation from the aircraft's core components. Consequently, all signals between the second station transmitter system and aft transmitter anten-

At this point, the entire tail assembly blew away from the forward two-thirds of the aircraft. Moments later, the eleven intermediate hinges failed that attached the rudder to the vertical fin. When the top and bottom hinge brackets gave way, the rudder separated completely. Per engineering predictions, the rudder deflection angle had stabilized at 12 degrees to the right following engine spool-down.

The second change was a physical strengthening of the vertical fin and associated fuselage structure just forward of the tail. New aircraft were built with these modifications integral to the flight control system and structure, respectfully.

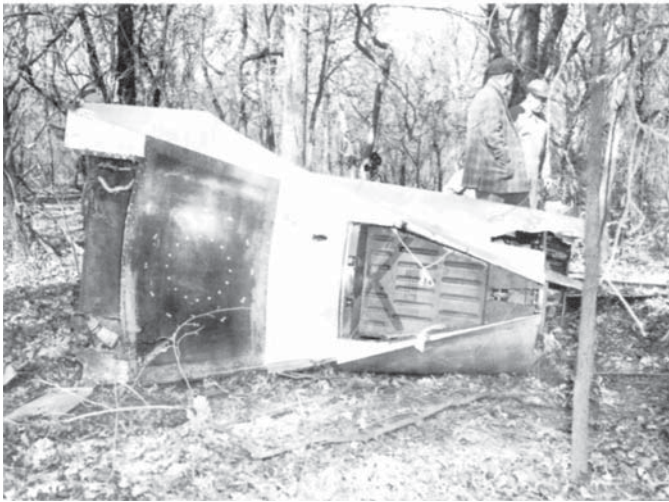
6: Empennage and vertical tail of '5664 as it was found in a field outside Duncan, Oklahoma. Telemetry antenna for the data relay system was located inside the area covered by the black dielectric panel with the circular pattern on it. Triangles mark points where strain gauges were located. (Photo from General Dynamics)

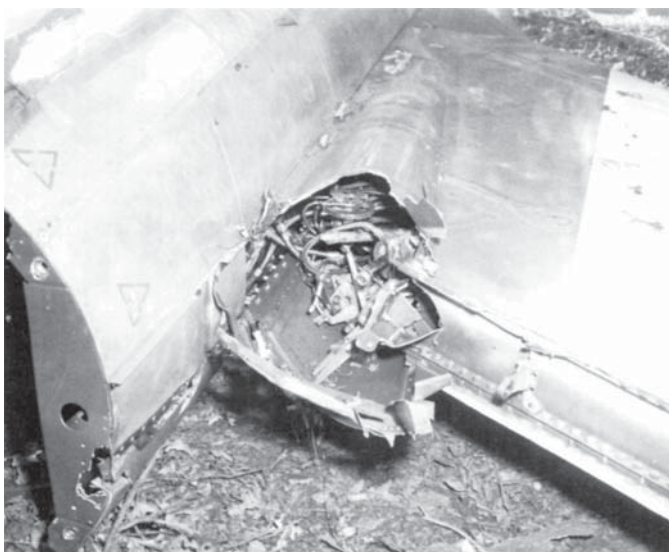
7: The hydraulic actuator assembly for the rudder was completely destroyed when the rudder separated from '5664's vertical fin at nearly twice the speed of sound. (Photo from General Dynamics)

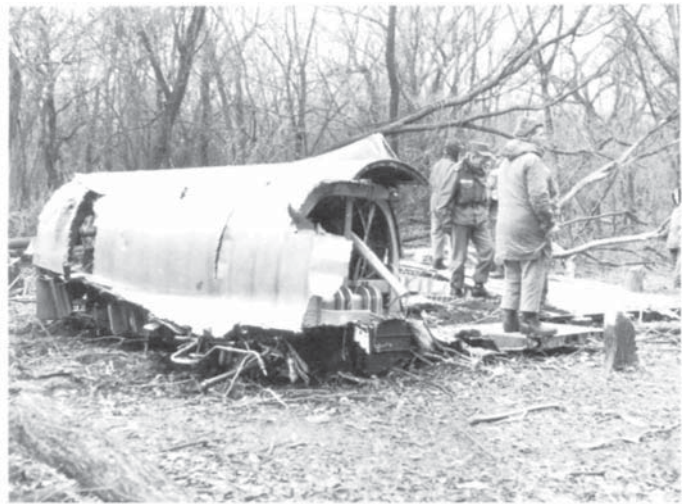
8: '5664's aft center fuselage section with right wing panel partially attached. Severity of damage underscored how completely the airplane was destroyed as a result of the enormous aerodynamic loads imposed at 2.0 Mach. (Photo from General Dynamics)

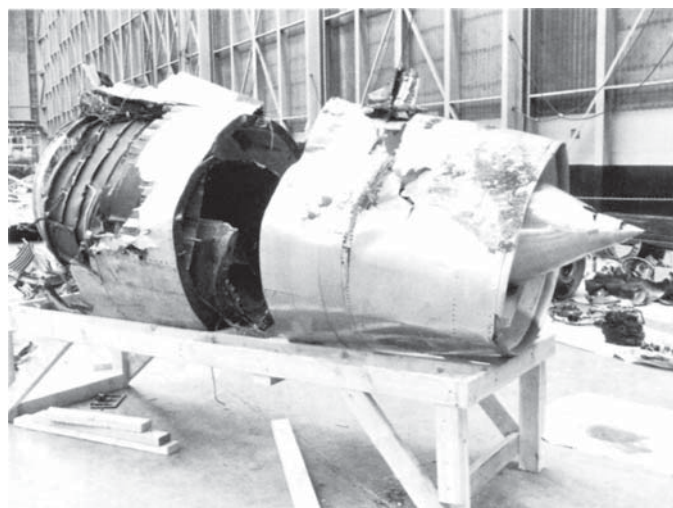
11: The forward section of the number 3 engine nacelle. Damage to this suspect part did not yield any clues indicating whether it had played a prominent role in the loss of '5664. (Photo from General Dynamics)

(1) Increased drag on the right side of the aircraft due to the unexpected parallel loss of the number 3 engine. The latter was attributed to "blanking" of the number 3 engine's intake airflow by the fuselage as a result of the yaw angle to the line of flight.

(2) Loss of thrust in the number 3 engine caused by the ingestion of the right nose landing gear door at the onset of the initial yaw divergence.

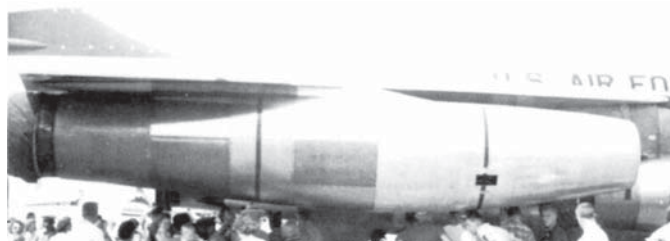
With the virtually instantaneous loss of thrust suffered by the number 4 engine, the resulting asymmetric drag immediately skewed the aircraft to an angle of 3.2 degrees to the right of the direction of flight. As residual jet fuel flowed into its combustion chamber, the number 4 engine momentarily came back to life. For just a second, '5664 stabilized, but at the very point where it should have begun to recover, a second yaw oscillation pushed the angle of divergence even further to the right...to an untenable 12 degrees off center. Now, without any kind of corrective rudder action, and a vertical tail that - because it was bending in an ever more severe arch toward the right side of the aircraft - had limited ability to provide a correcting force, all remaining directional control was lost.

17: Right outboard engine nacelle. This was the engine that was purposefully failed for the ill-fated November 9th flight.

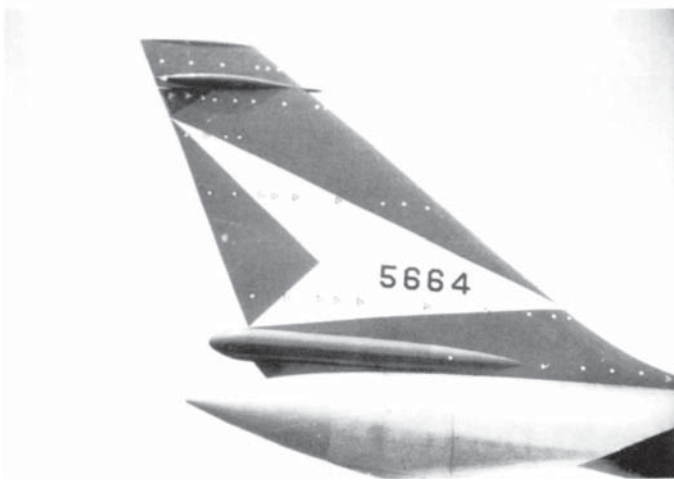
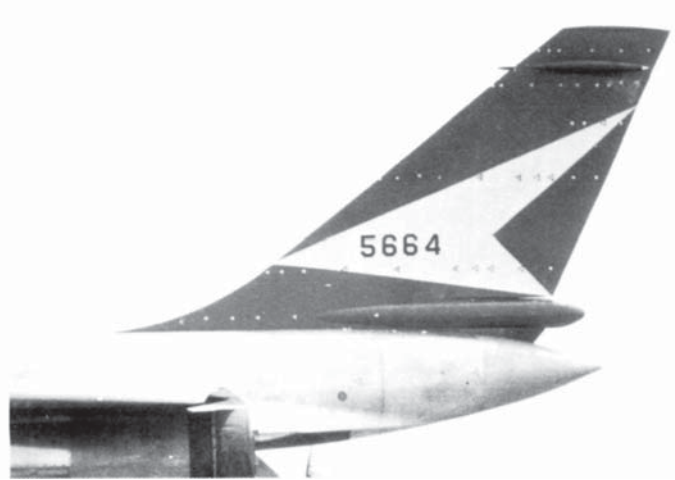
18/19: Two views of '5664's vertical tail. Strain gauge locations are readily discernible as each is marked with a colored triangle. Triangle pattern was mirrored on both sides of the fin and rudder.
