Dr. DOUGLAS H. ROBINSON\*  
 Pennington, N. J.

## "HINDENBURG" RETROSPECT

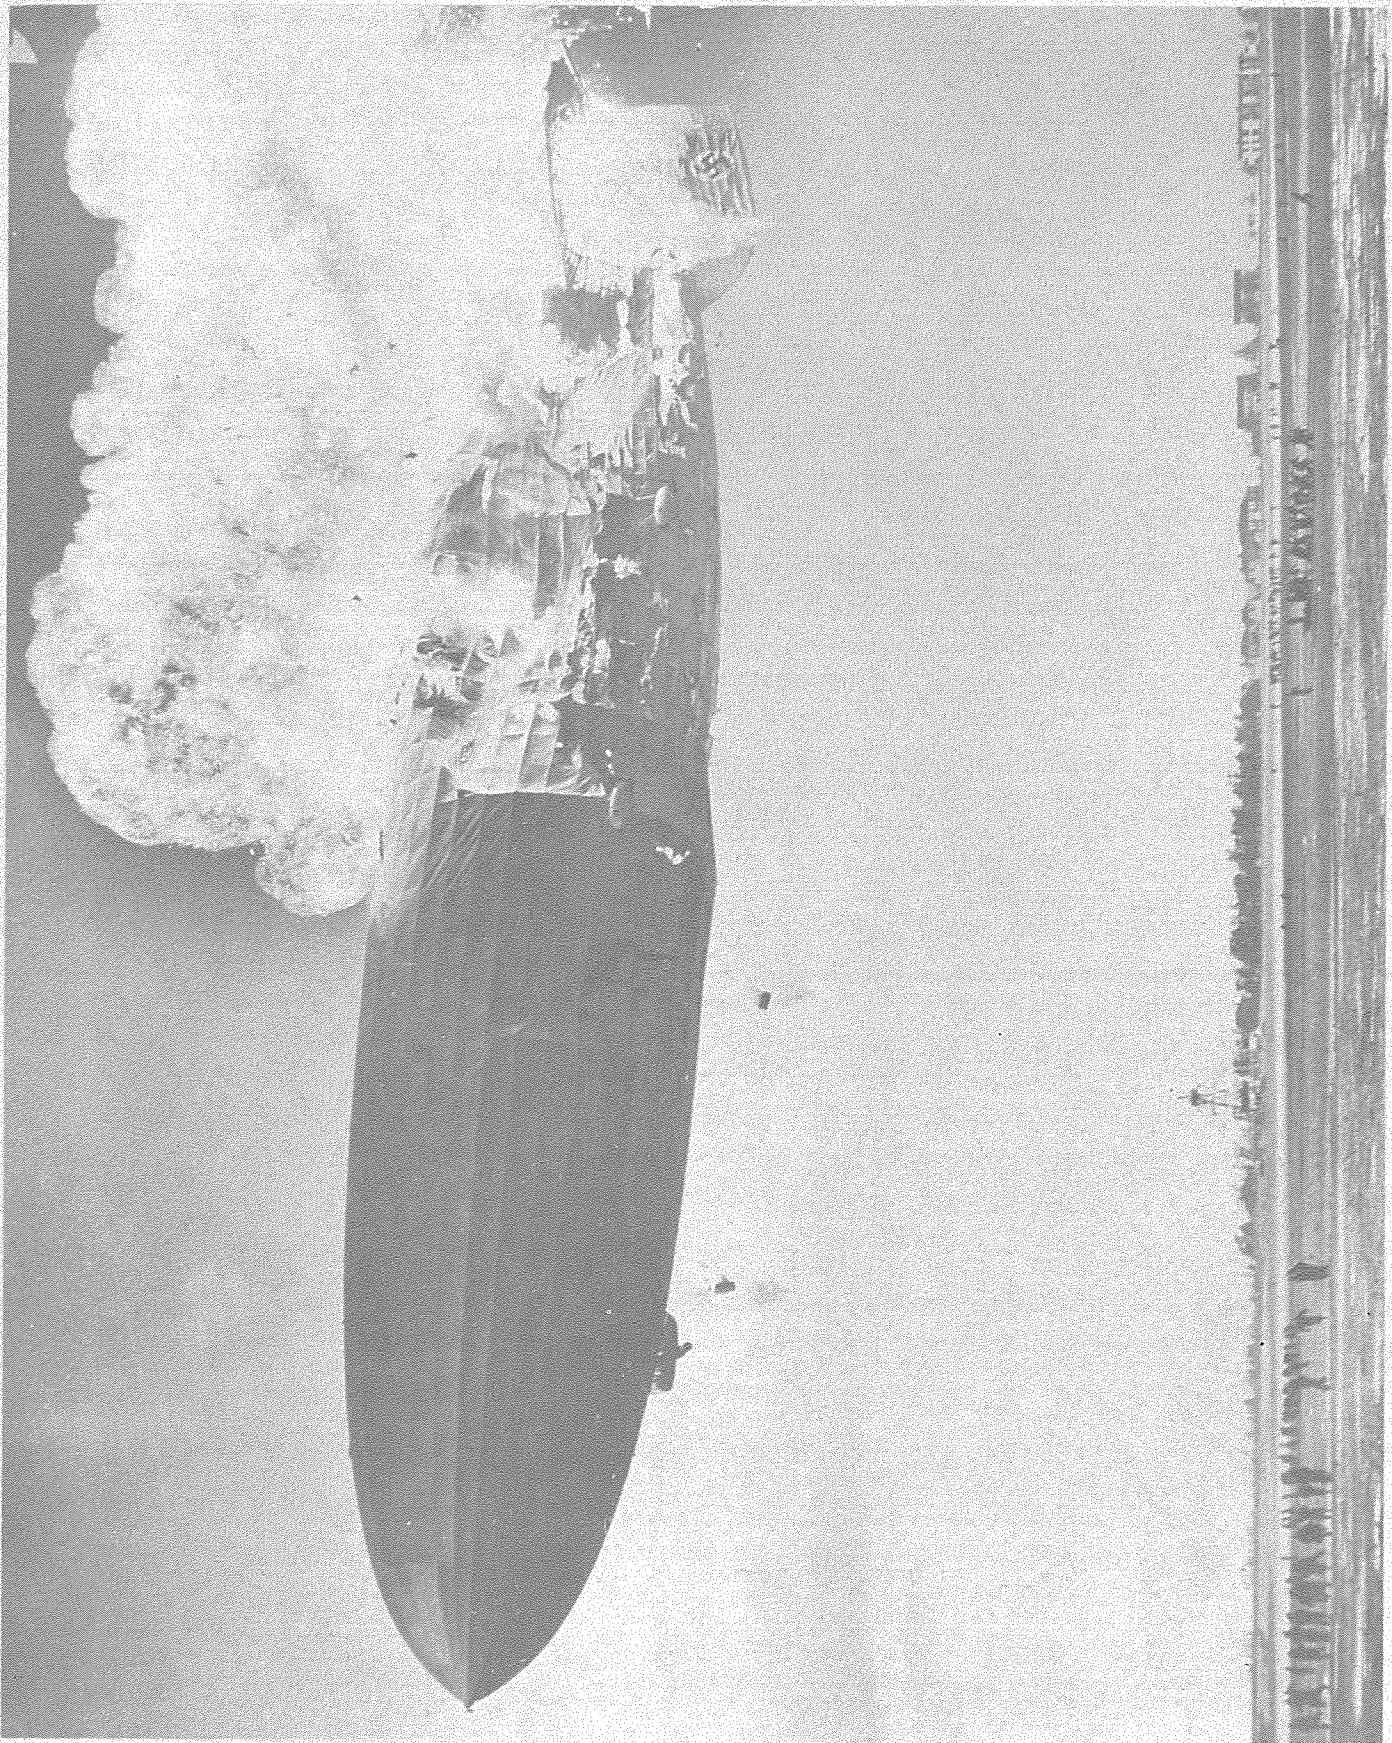
END OF AN ERA OF AERONAUTICAL GREATNESS
