# CRUNCHED ALUMINUM

## Rebuilding a Boeing 747-200B in Alaska

by Dave Stern

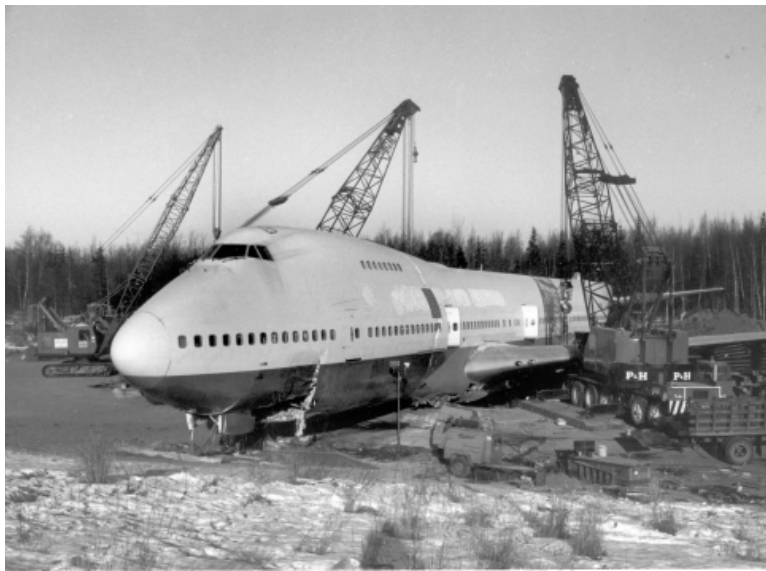
*With its airliner name, logo and registration number obliterated and now representing Nobody Airlines, the JAL 747-200B has its fin-rudder removed. Lower chine crack and one just ahead of the wing-root right up to a side exit door is seen in this photo. (JAL photo)*

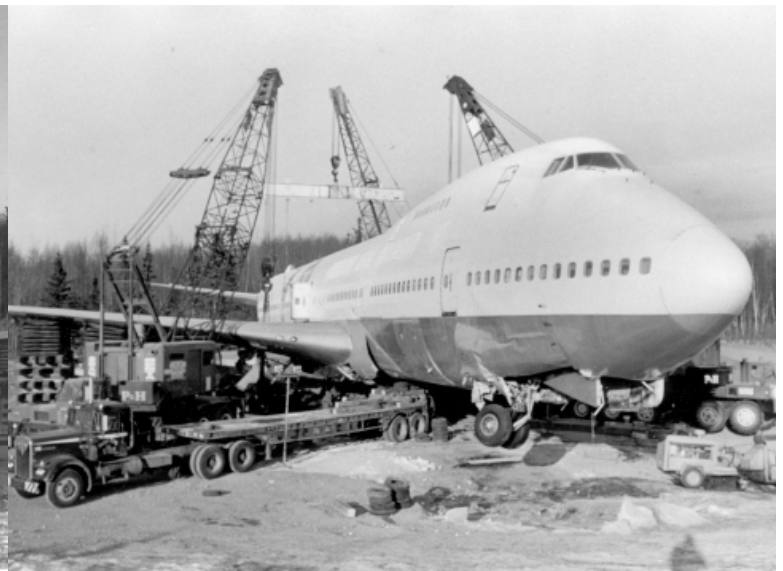
*JAL 8122's severe chin and nose landing gear damage is seen here as the plane is slowly hoisted into the air. Airbags support the wings while the engines appear to have been removed. (JAL photo)*

be towed backwards to the north ramp by two Cat 988 loaders - two graders with cables attached to each wing landing gear served as brakes. Since the nose gear had been nearly torn away from its support bulkhead, the nose was chained down to the crossbeams of a logging trailer, then the gully was filled in thus allowing the aircraft to be slowly and carefully towed over it.

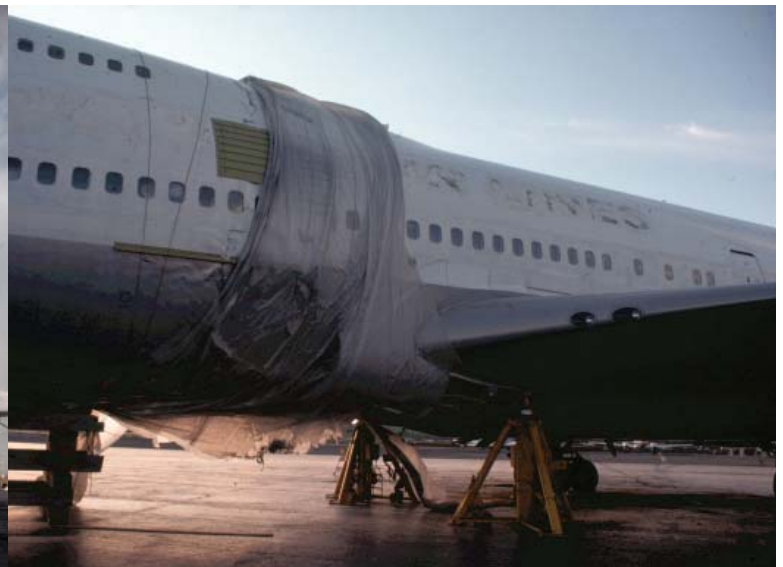
*The large fuselage crack extending on both sides of the spine is protected from rain and snow until the AOG Team arrives. Heavy support jacks prevent 8122 from shifting during high winds. (Photo by the author)*

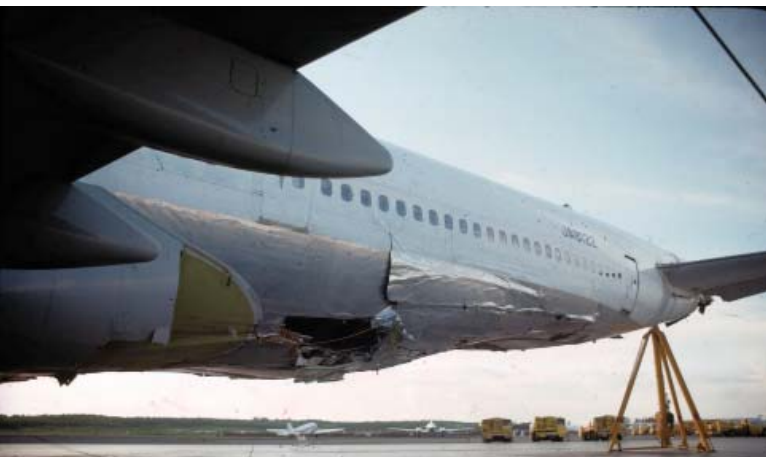
*Damage to the lower aft fuselage is observed in this photo and tail stand to support the tail from shifting during further high winds. (Photo by the author)*

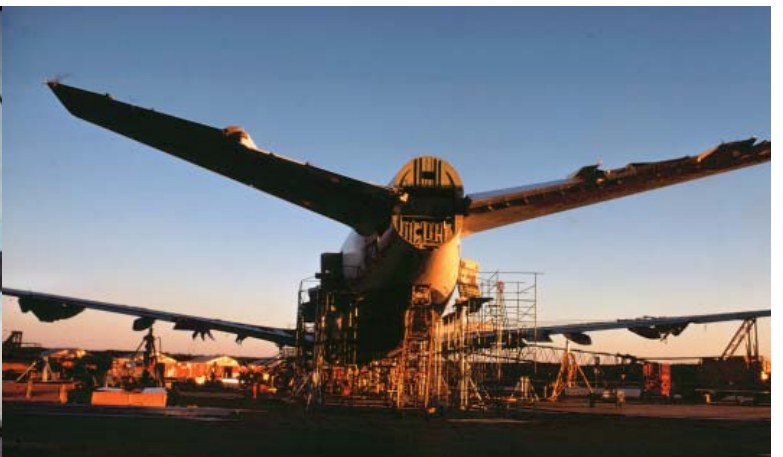
*Twigs from trees are visible that were jammed into the stabilizer during 8122's violent ride in reverse. It literally mowed down trees during the slide. The photo taken at dusk on the north ramp. (Photo by the author)*

four engines were extensively damaged and the horizontal tail surfaces were mauled since they acted like a saw, cutting down trees and saplings during the aircraft's short, violent and undignified rearward slide.

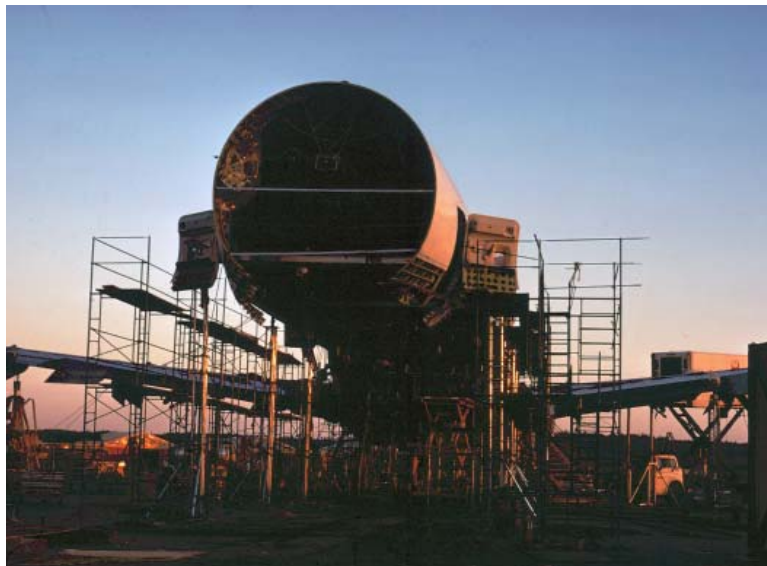
*The AOG Team at work. Cranes have removed the rear fuselage and tail assembly to facilitate major repairs. Forward fuselage scaffolding is seen on each side of the giant mid-fuselage crack. (Photo by the author)*
