# The Operational History and Resurrection of Zero-Two-Nine

By John Vadas

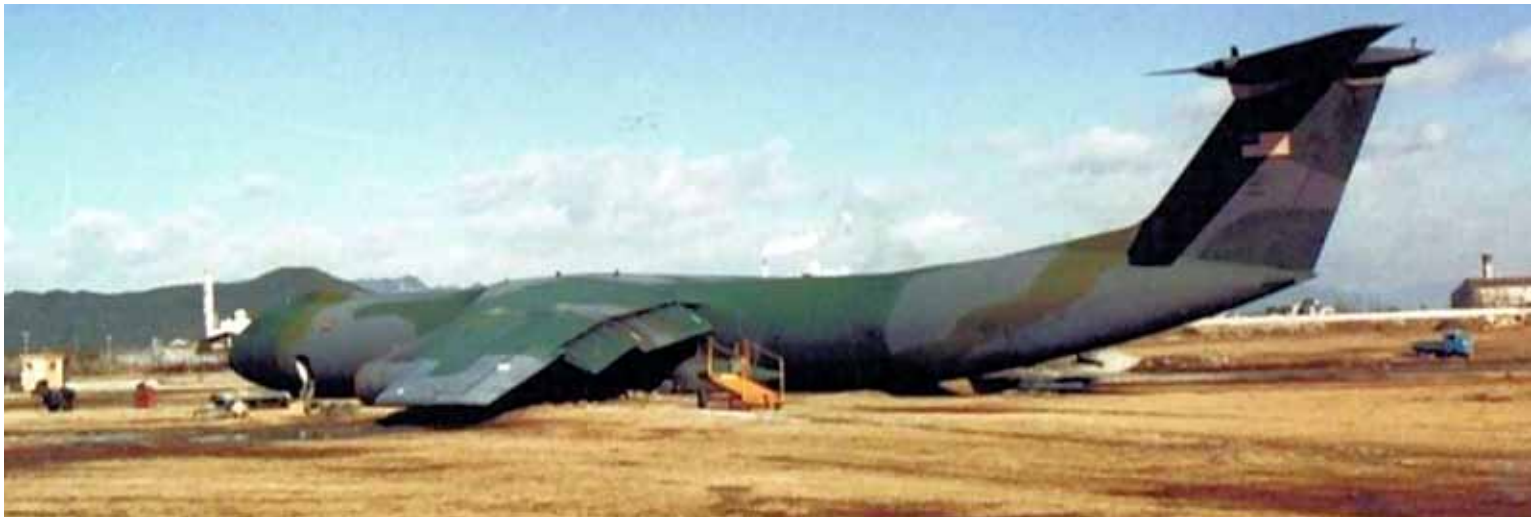
The pilot lost control of the aircraft on the snow-slickened pavement, and the aircraft departed the runway. The landing gear collapsed, the right wing suffered severe damage and the No. 4 engine separated from the wing. The crew and passengers evacuated successfully."<sup>5</sup> \*

67-0029 where she ended up off the end of the runway at MCAS Iwakuni. (Photo from the Paul Minert collection)

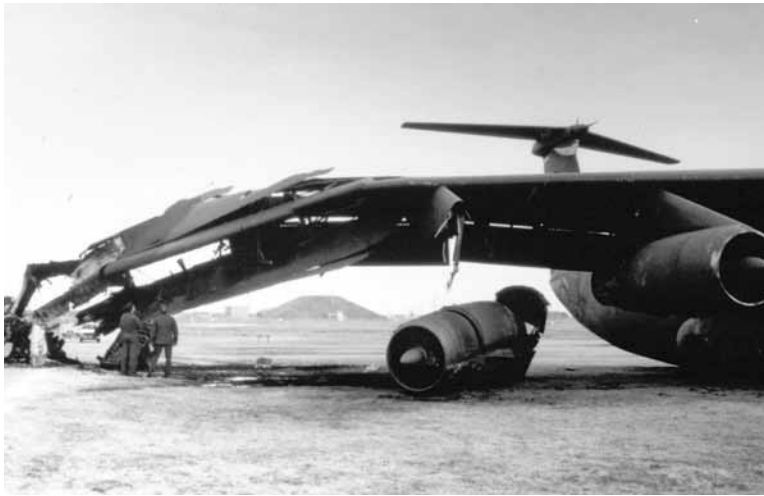
The damage to the right wing and no. 4 engine was extensive.<sup>7</sup> (USAF photo)

It was decided that the right wing from 65-0246, which had been in storage for a year and a half, would provide a suitable replacement for the damaged wing on 67-0029 and put at least one of the aircraft back in service.

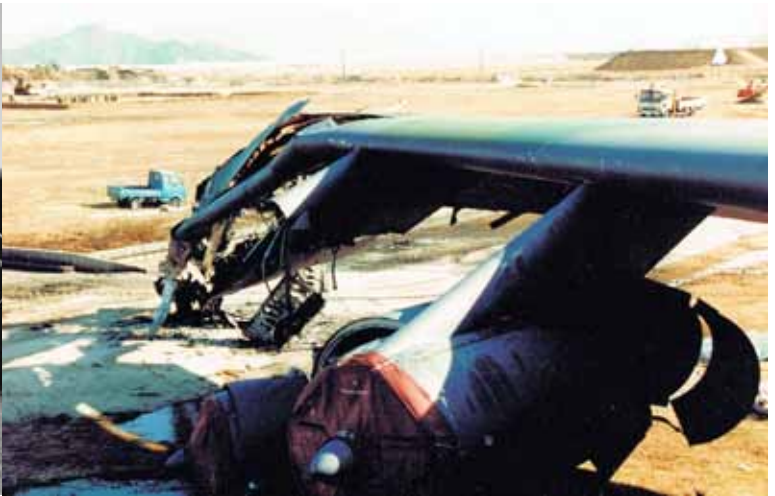
Note the thrust reverser on no. 3 engine is still deployed. (Photo from the Paul Minert collection)

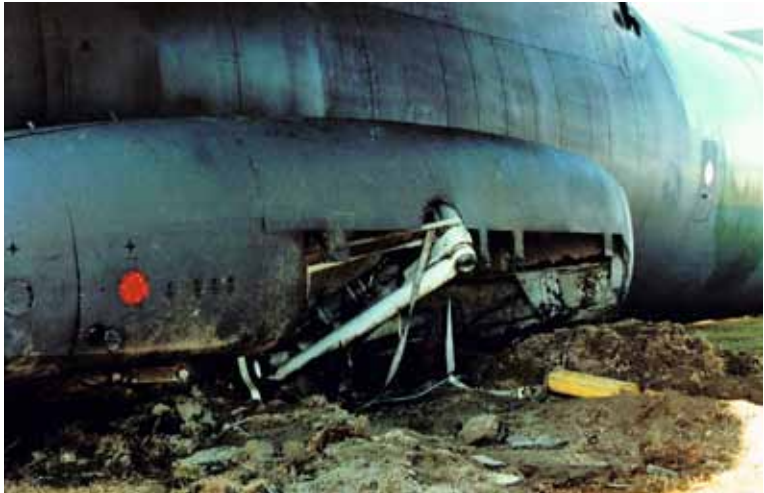
The extensive damage to the right main landing gear assembly is evident in this photo. (Photo from the Paul Minert collection)

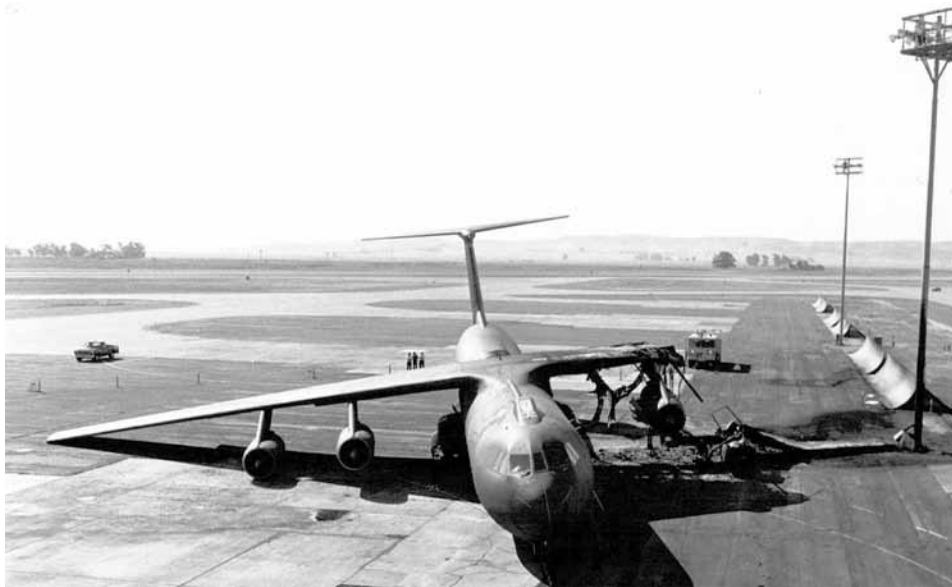
*The remains of 65-0246 after striking a light pole at Travis AFB on the night of October 15, 1986.<sup>14</sup> (USAF photo)*

parking. The aircraft commander twice deplaned the scanner to complain about the marshalling procedure. Finally, convinced by the lead marshaler, and with a wing walker on each wing and a pilot in the left window, they followed the marshaler's instructions. While starting a hard right turn, the crew felt a bump. The left wing had struck a light pole which ruptured the no. 1 main fuel tank. Fuel ran down the light pole and into a high voltage junction box at the base of the pole, igniting a fire that spread back up the pole and onto the wing. The crew and passengers evacuated out through the crew entrance door. The fire department was able to contain the fire to the left wing.<sup>13</sup> After the accident investigation was completed, the wings were removed and the fuselage was used as a ground trainer at Travis AFB.

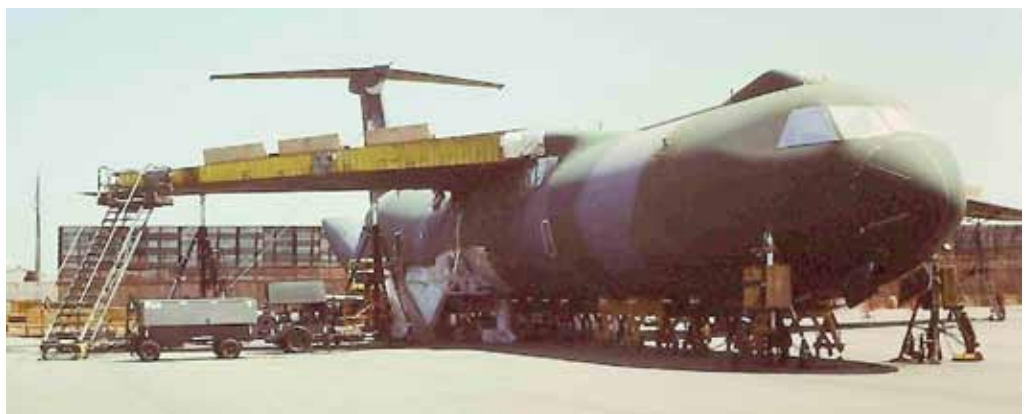
*67-0029 undergoing a wing replacement at Iwakuni AB. The inner portion of the right wing would be crated and sent to AMARC for storage. (USAF photo provided by Dave Grant)<sup>15</sup>*

A new relief team led by SMSgt. Benjamin Pate arrived at Iwakuni during August 1988. From August to October of that year, they installed the new right wing on the aircraft, installed the aircraft's main landing gears and engine
