## Mortality in Army Aviation

A document of considerable historic interest was prepared on 28 February 1914 by the Office of the Chief Signal Officer, War Department, Washington, D. C. and has been made available to the JOURNAL through the efforts of Member, Robert F. Brooks. Prepared as a Memorandum for the Chief of Staff, its subject is Mortality in Army Aviation, and the document traces in detail the 11 fatal aviation accidents which had occurred since the initiation of Army aviation in 1908. Excluding a brief introduction, the full report is presented herewith.

### BRIEF DESCRIPTION OF ACCIDENTS AND PROBABLE CAUSES

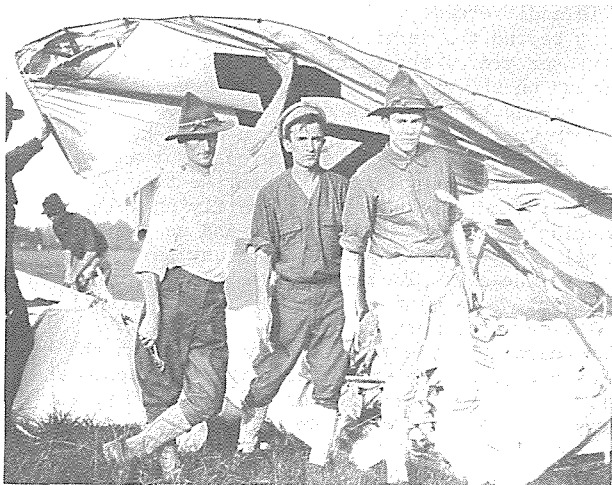
Immediately after the accident (September 28, 1912), the board proceeded to examine the wrecked machine and upon this examination found that the control wires were all intact. From the testimony of eye-witnesses, the board is of the opinion that the accident was caused by the aviator misjudging his height from the ground and his failure to bring the machine out of the glide in sufficient time to clear the ground.

Probable Cause of Accident: Error in judgment on part of pilot in not straightening up machine before striking the ground. (Both men killed.)

Three photos showing the wreckage of the Wright B, aircraft number 4, in which Lt. Lewis C. Rockwell and Corporal Scott lost their lives. The accident occurred at College Park, Maryland on September 28, 1912. (Photos Newscone, taken by MacCortee)
