# The Life of Douglas DC-2-118B, S/N 1368

By Bruce Cunningham

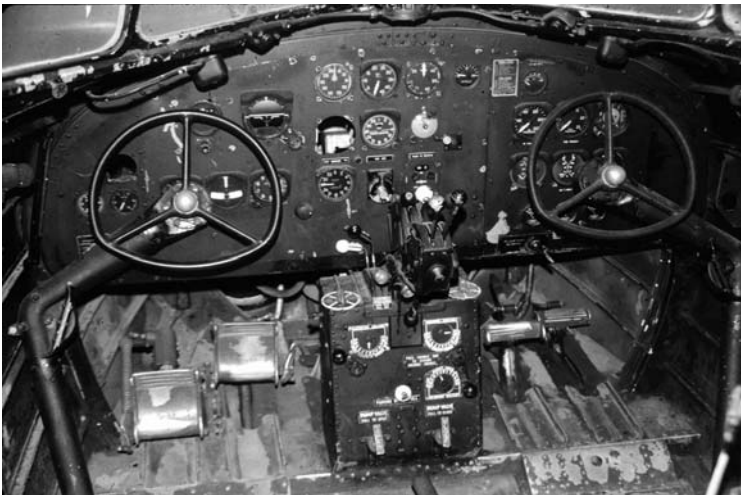
*Cockpit as flown by Johnson Flying Service and prior to modification by Douglas volunteers to include modern radio and navigation equipment to allow flight into FAA controlled airspace.*

and certified by a volunteer company, and returned for installation. New radios were purchased and installed to allow flights into and out of controlled airports. All hydraulic components including the reservoir, pressure accumulator, pumps, actuating cylinders and selector valves, went to local companies that volunteered to help and where specialists put them through the overhaul process and certified them as airworthy.

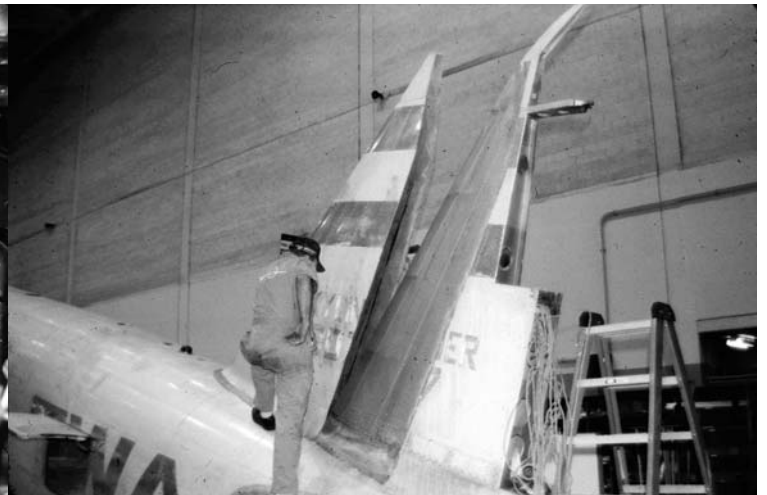
*Removing the vertical fin leading edge for reconditioning. This was an add-on to overcome the lack of directional control after losing one engine on takeoff.*

In removing the vertical fin, more history was brought to light. Investigation disclosed that an early American Airlines DC-2 got into a spin when it lost an engine on takeoff. Only through rapid and correct reactions by the cockpit crew prevented a possible fatal crash. It developed that the width (chord) of the vertical fin was not sufficient to allow recovery from a spin under certain flight conditions. Douglas engineers designed a triangular "glove" to be installed by the airlines, if desired, over the leading edge of the fin. This "glove" added 24 inches to the chord of the lower section of the fin and six inches to the upper chord, thus increasing the area of the fin by approximately 25 percent. This modification resulted in a large increase in directional control and stability.

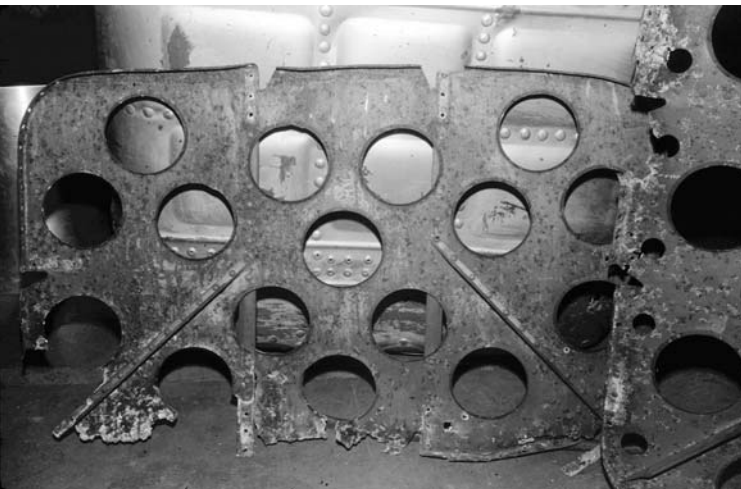
*Photo showing condition of a fuel tank prior to reconditioning and rebuilding.*

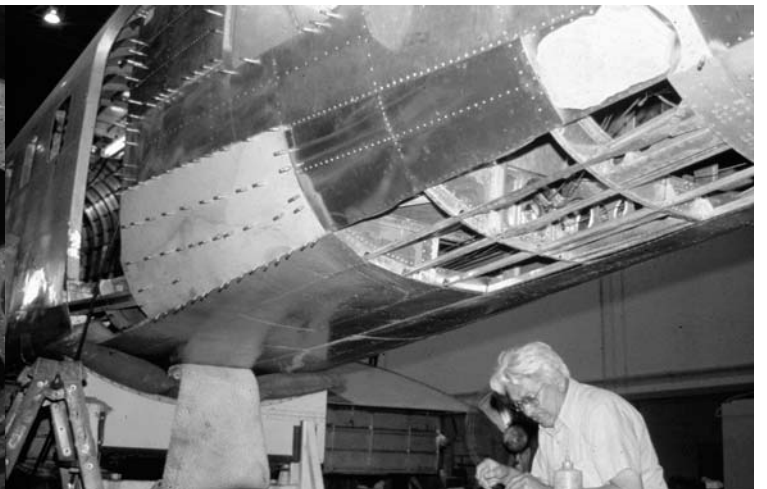
*Replacing fuselage exterior skin that had been severely dented skin that had been damaged by the parachute lanyards during jumps by fire fighters at low altitudes into fire areas.*

In the mean time working volunteers were replacing external skins aft of the main entrance door that the fire jumpers parachute lanyards had dented and scratched when bailing out. All control surfaces were removed, inspected and re-covered by volunteers.

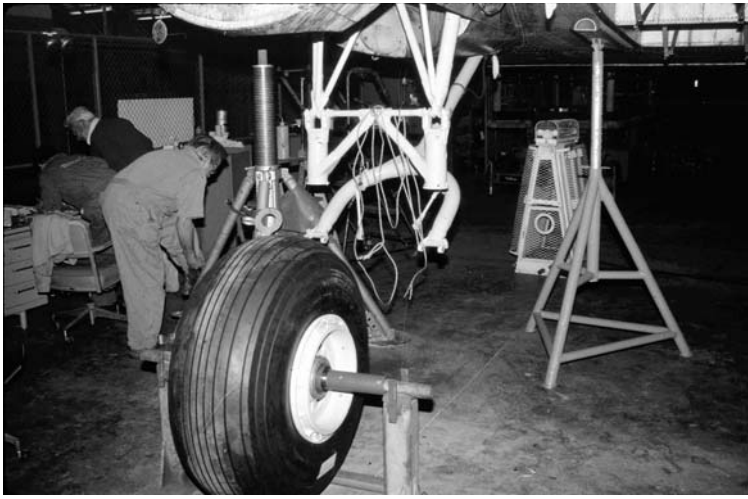
*Assembly and installation of reconditioned landing gear components.*

As information spread through the aircraft community, calls began coming in from those who wanted to help. The original manufacturer of the landing gear requested that we send the complete gear and brake assemblies to their factory for a complete refurbishment. One of the larger package delivery airlines offered to fly the landing gear to the company in the Midwest who had manufactured them over 48 years ago, and then return them when the job was completed.
