# Flying Aircraft Carriers of the USAF: Project FICON

## Section 4: Systems and Operations

By Brian Lockett

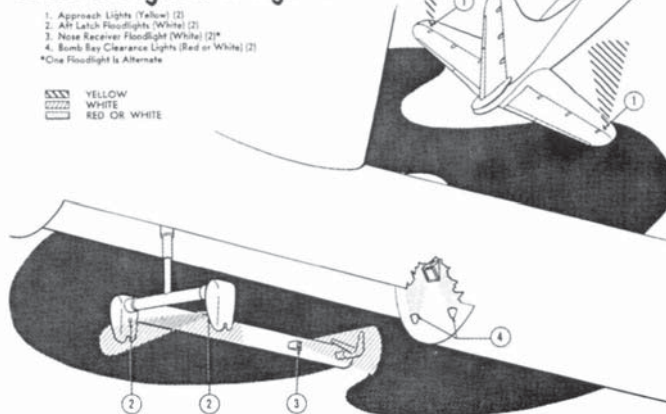
### Exterior Lights Arrangement

Exterior Lights Arrangement Diagram from the Utility Flight Handbook for the GRB-38D-III Featherweight Configuration III/RF-84F Composite Aircraft. (Roger Cripliver)

White floodlights were installed on the trapeze to illuminate the nose receiver and each of the aft latches. Another floodlight was mounted on the boom, pointing forward to illuminate the receiver. It was equipped with a backup lamp in case the primary lamp burned out. A floodlight was mounted in each aft latch housing, pointing across to the opposite latch.

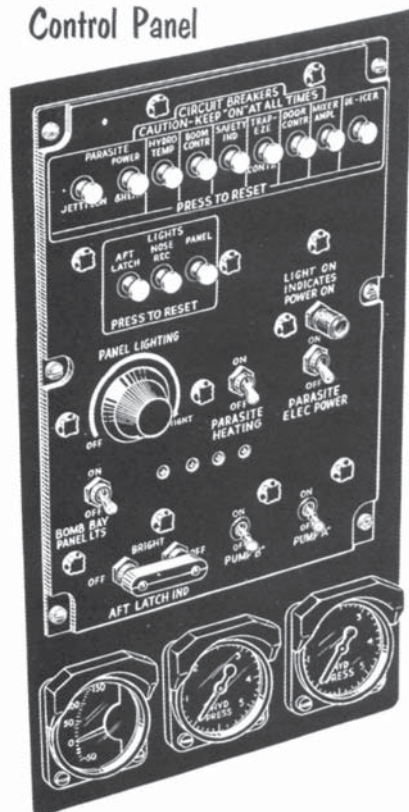
## Trapeze Operator's Auxiliary Control Panel

1. CIRCUIT BREAKER PANELS
2. BOMB BAY PANEL LIGHT SWITCH
3. PANEL LIGHT CONTROL KNOB
4. PARASITE PREHEAT SWITCH
5. PARASITE ELECTRICAL POWER SWITCH
6. PARASITE POWER-ON INDICATOR LAMP
7. AFT LATCH INDICATOR LIGHTS SWITCH
8. HYDRAULIC PUMP SWITCHES
9. HYDRAULIC TEMPERATURE GAUGE
10. HYDRAULIC PRESSURE GAUGES
