# THE LAST FLIGHT OF LAWRENCE B. SPERRY

by Victor N. Smith

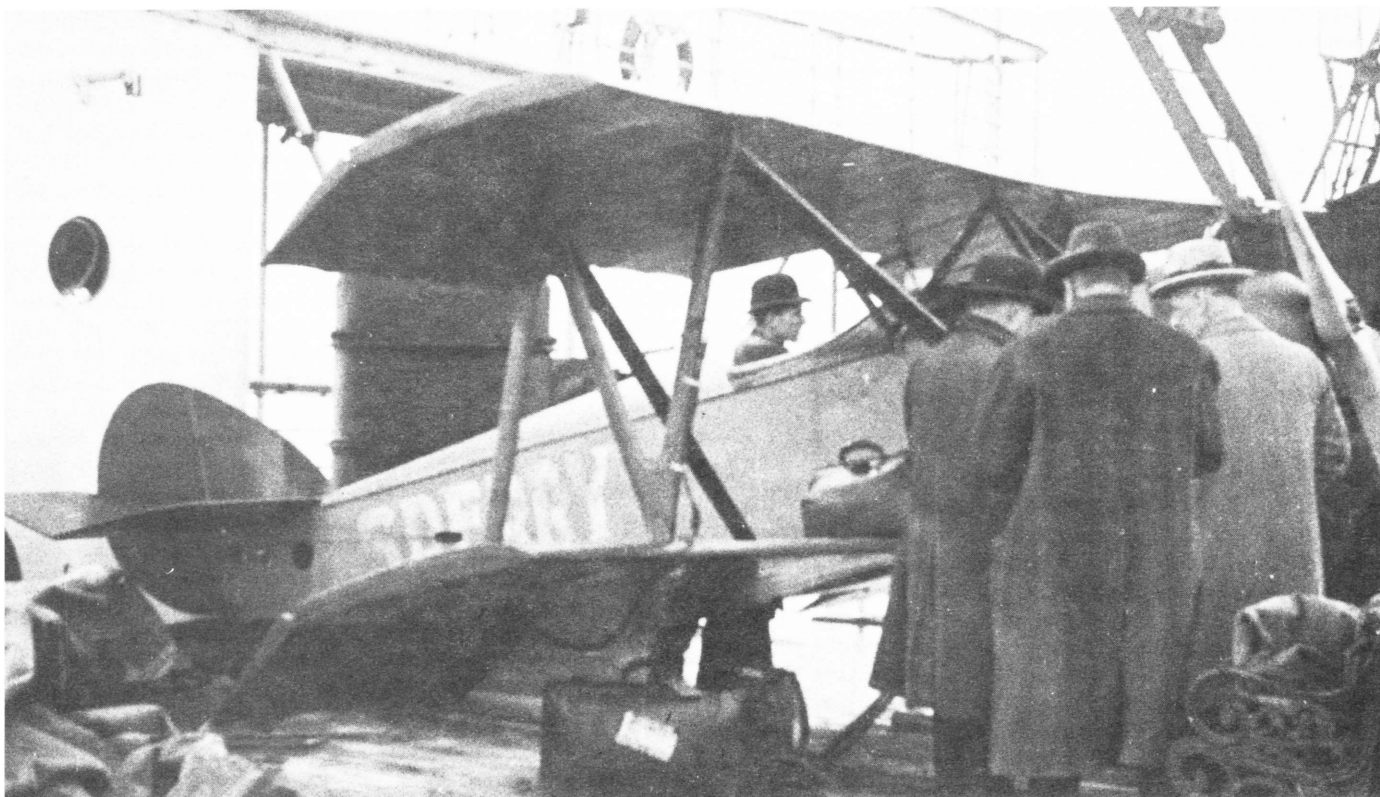
Reporters examine the Sperry Messenger, which has no markings except the maker's name.  
(E.M.I. Pathe Library, film still)
