# THE LAST FORMAL ACT

by Jay Miller

Underscoring this lack of technological maturity more than any other *Hustler* accident was the loss of the fifth B-58A, AF serial number 55-664, on November 7, 1959, in the skies over

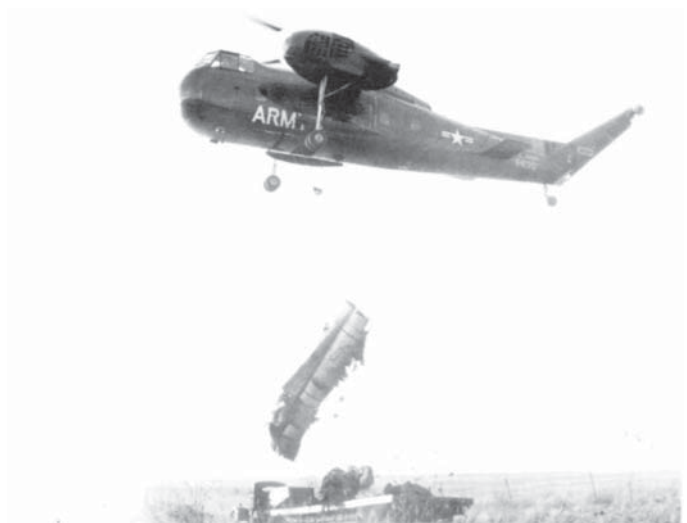
9: Workhorse of the parts location and retrieval team was a single Sikorsky H-37. Its heavy lift capabilities allowed it to haul the biggest chunks of 5664, such as this engine nacelle component (note engine already on flatbed), to the truck and trailer units tasked with transporting everything back to Ft. Worth. (Photo from General Dynamics)

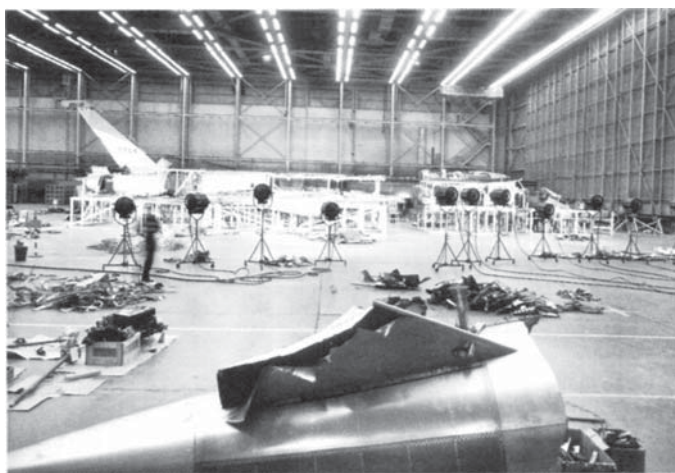
10: Remains of '5664 were transported by truck from Oklahoma back to Convair's Ft. Worth plant for partial reassembly in an attempt to ascertain the cause of the accident. In the foreground is the tail of the aircraft's MB-1 pod. (Photo from General Dynamics)

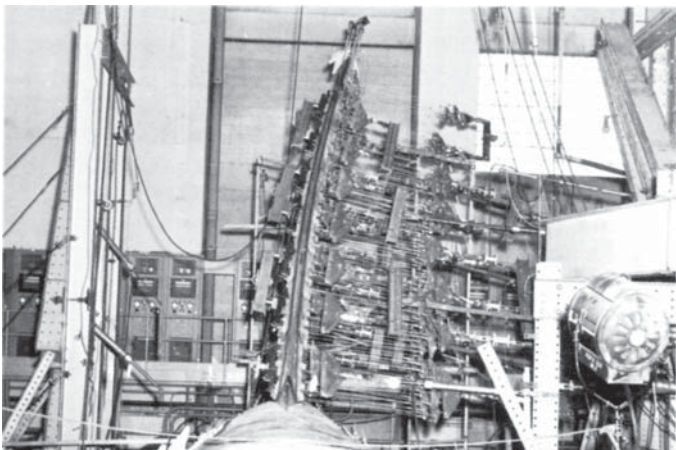
14: Structural testing of "number 4A's" vertical tail at 90% of design ultimate load. This test was conducted less than a month after the crash of '5664. (Photo from Wright Air Development Center)
