Dr. DOUGLAS H. ROBINSON\*  
 Pennington, N. J.

## "HINDENBURG" RETROSPECT

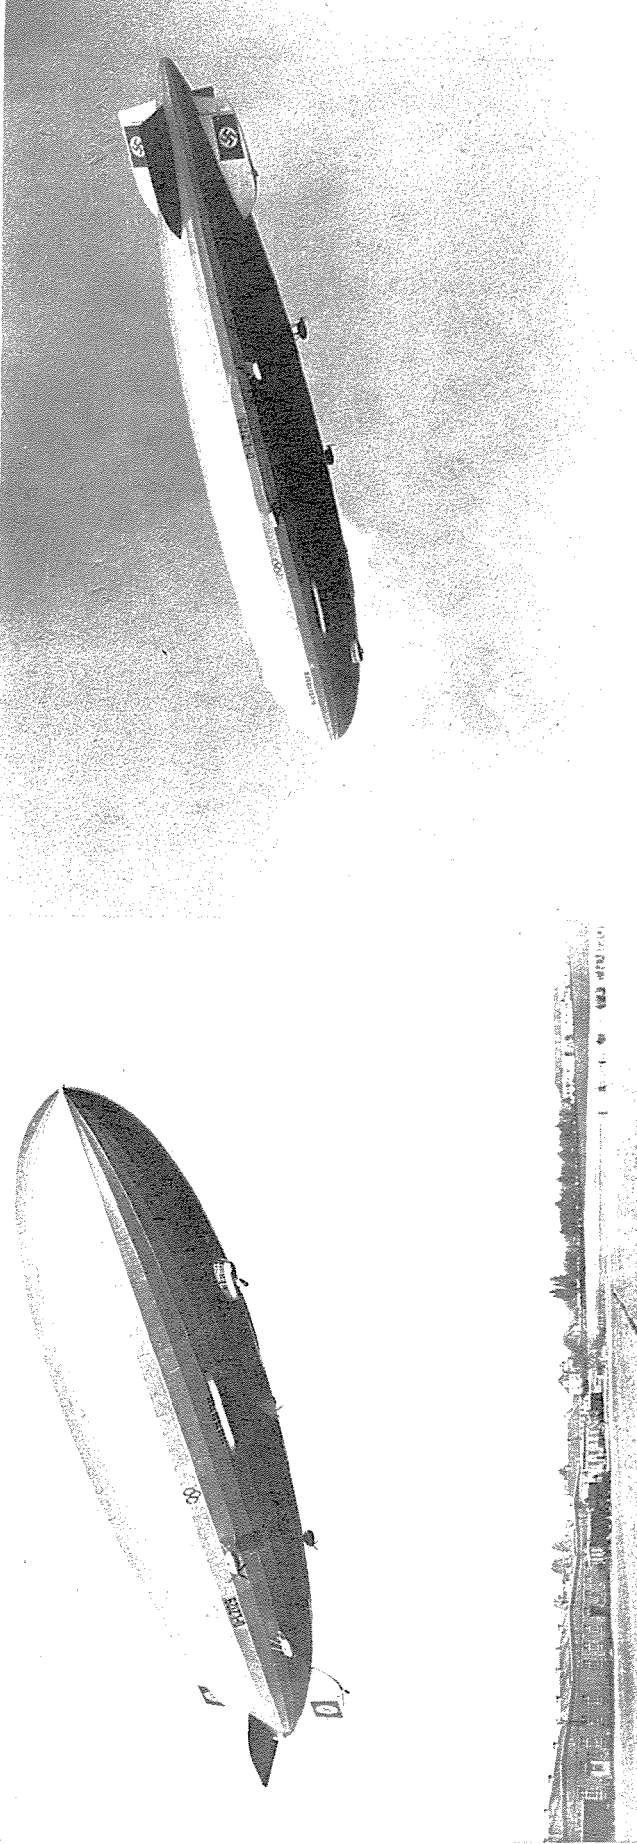
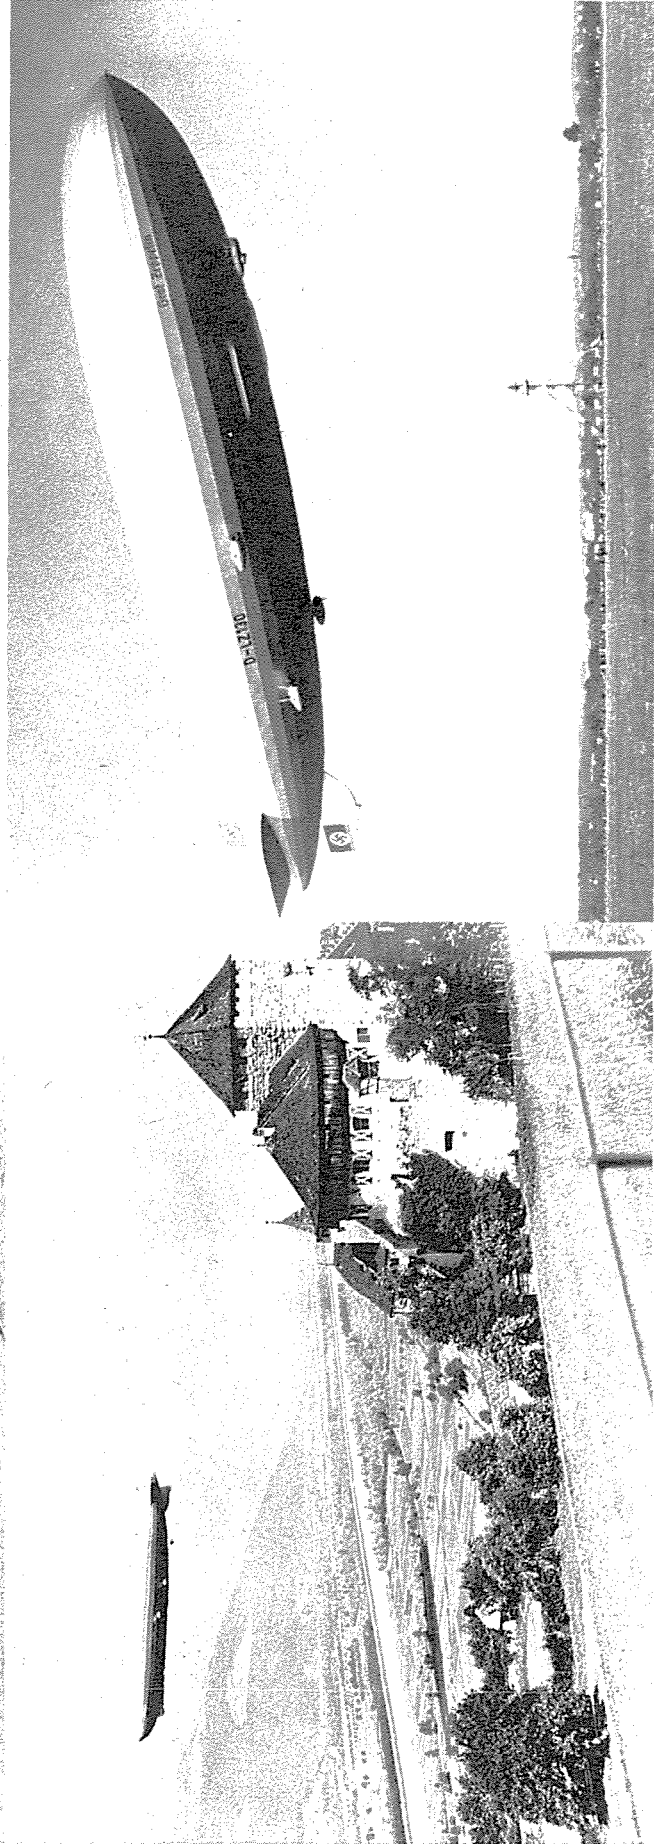
THE GREAT GERMAN RIGIDS - "HINDENBURG" and "GRAF ZEPPELIN"

Upper - Early trial flight of the LZ-129 "Hindenburg". The name was not yet painted on the bow. (Koch)
