# CRUNCHED ALUMINUM

## Rebuilding a Boeing 747-200B in Alaska

by Dave Stern

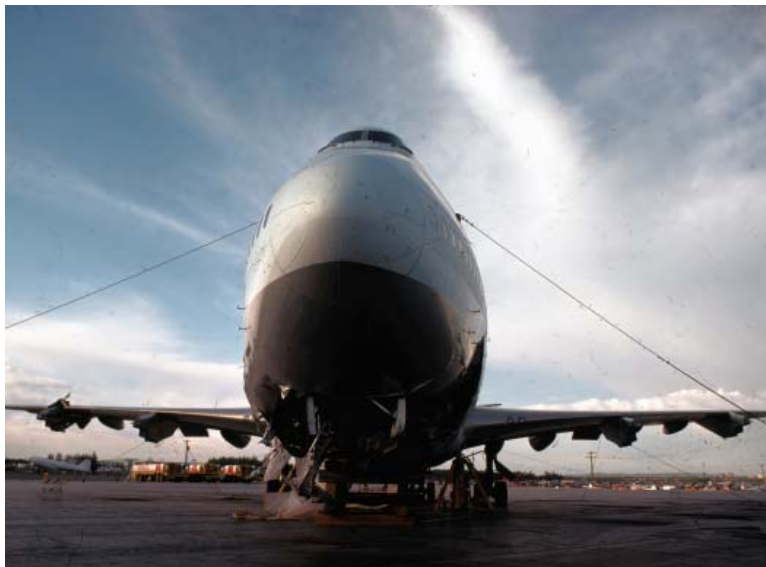
*JAL8122 is moored to the east side of the north ramp of Anchorage International Airport after being towed from the gully along the east-west taxiway. (Photo by the author)*

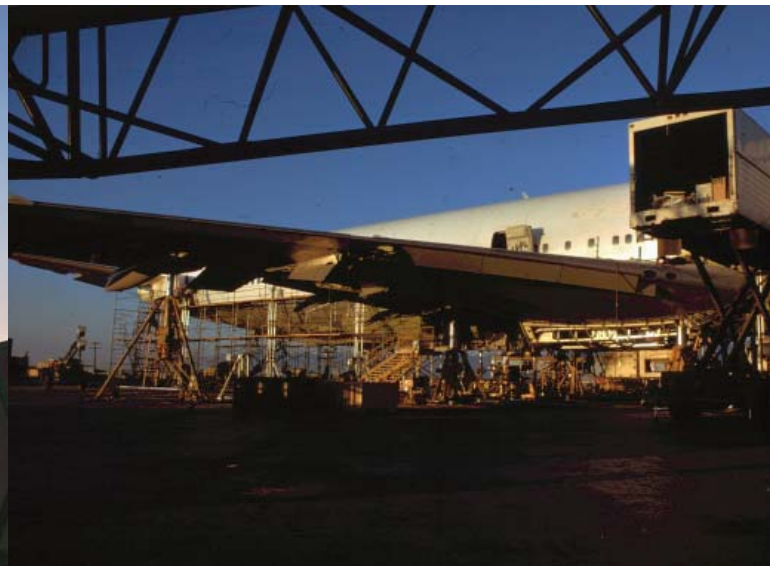
*The sun slowly sets as the JAL 747 undergoes major repairs — a JAL cargo container provides 747 parts from its home base in Japan. (Photo by the author)*
