# The Operational History and Resurrection of Zero-Two-Nine

By John Vadas

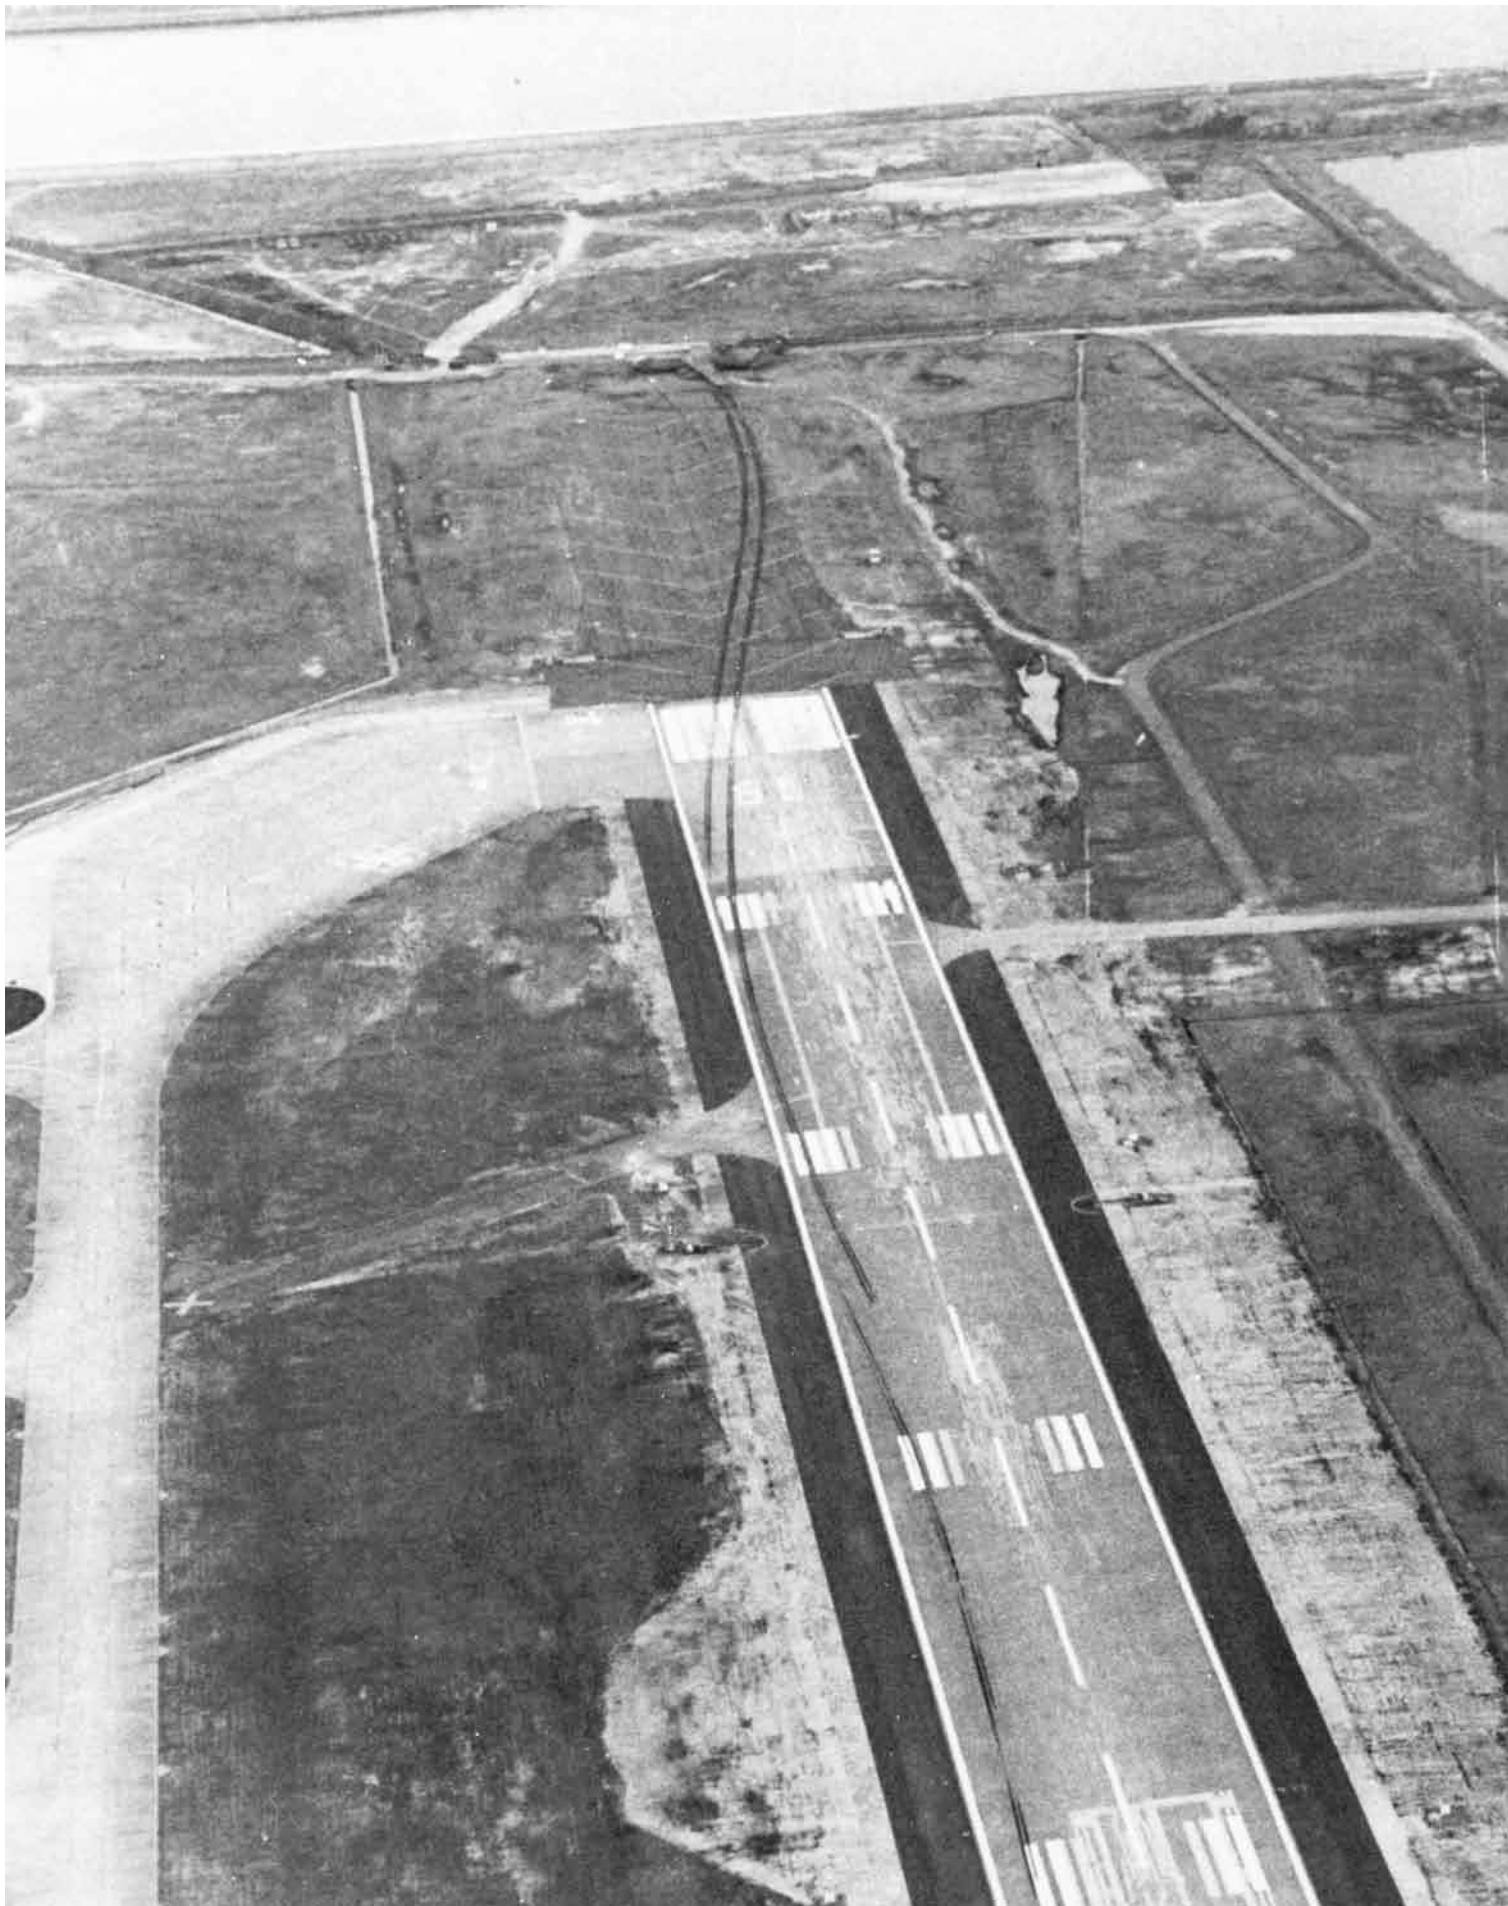
"Aircraft 67-0029 had a bad day at Iwakuni AB, Japan, on January 12, 1987. After landing in blowing snow and high winds, it ran off the runway and the right wing was damaged severely," said Col. Paul Hansen.<sup>4</sup>

The pilot lost control of the aircraft on the snow-slickened pavement, and the aircraft departed the runway. The landing gear collapsed, the right wing suffered severe damage and the No. 4 engine separated from the wing. The crew and passengers evacuated successfully."<sup>5</sup> \*

*An aerial view of the runway at MCAS Iwakuni showing the landing path of 67-0029.<sup>6</sup> (USAF photo)*

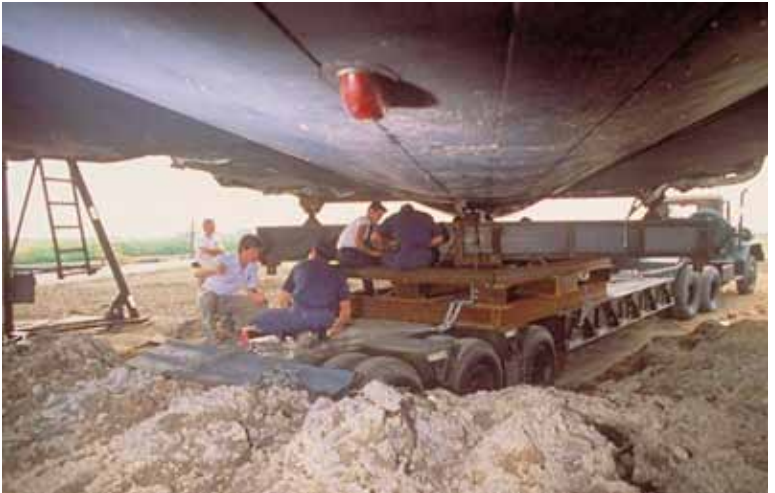
A dedicated team preparing the aircraft for movement. (USAF photo from the Dave Grant collection)<sup>8</sup>

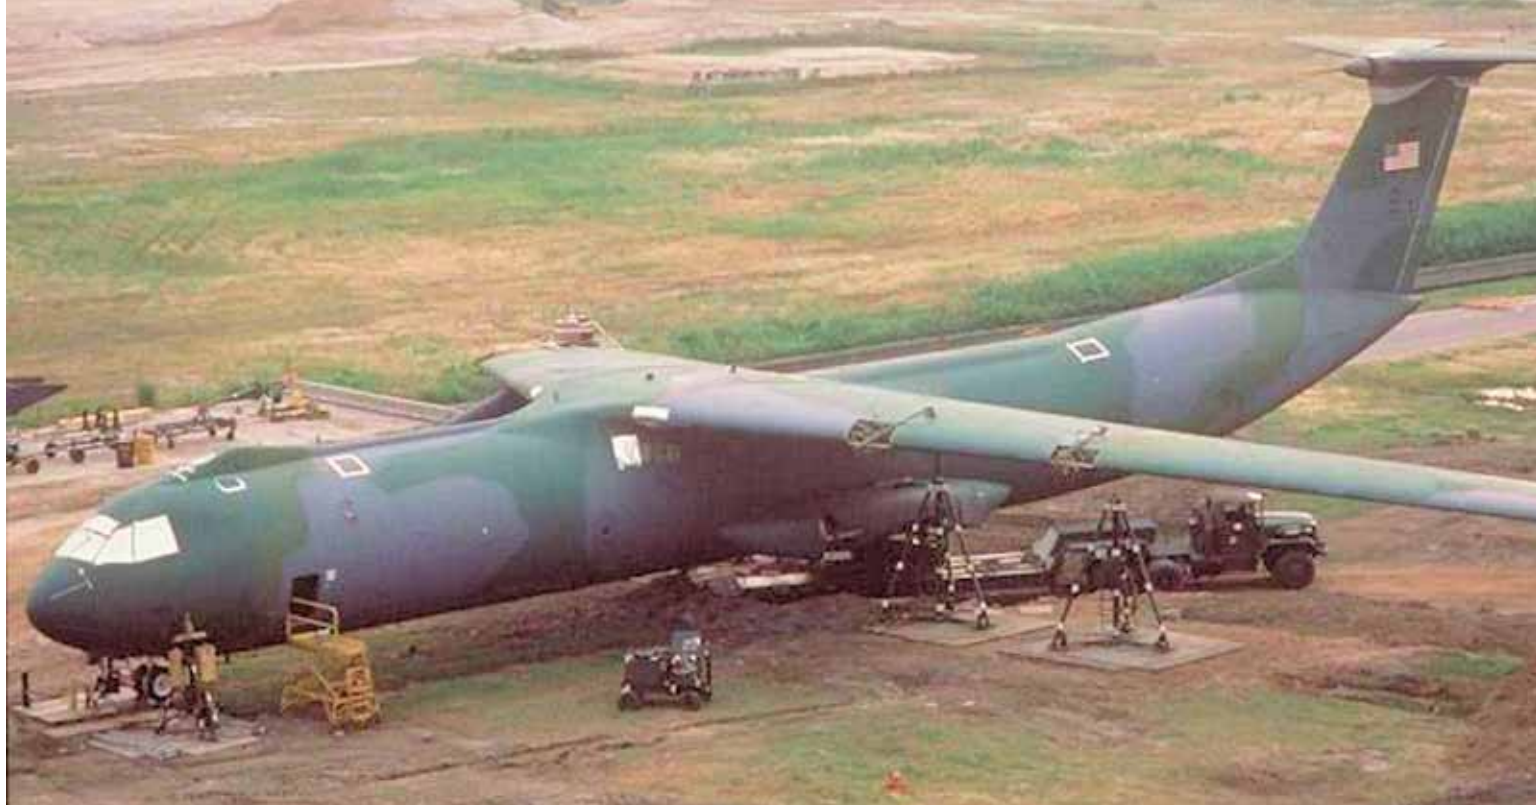
*The weight of the aircraft is almost off the wing jacks and onto the truck trailer. (USAF photo from the D. Grant collection)<sup>9</sup>*

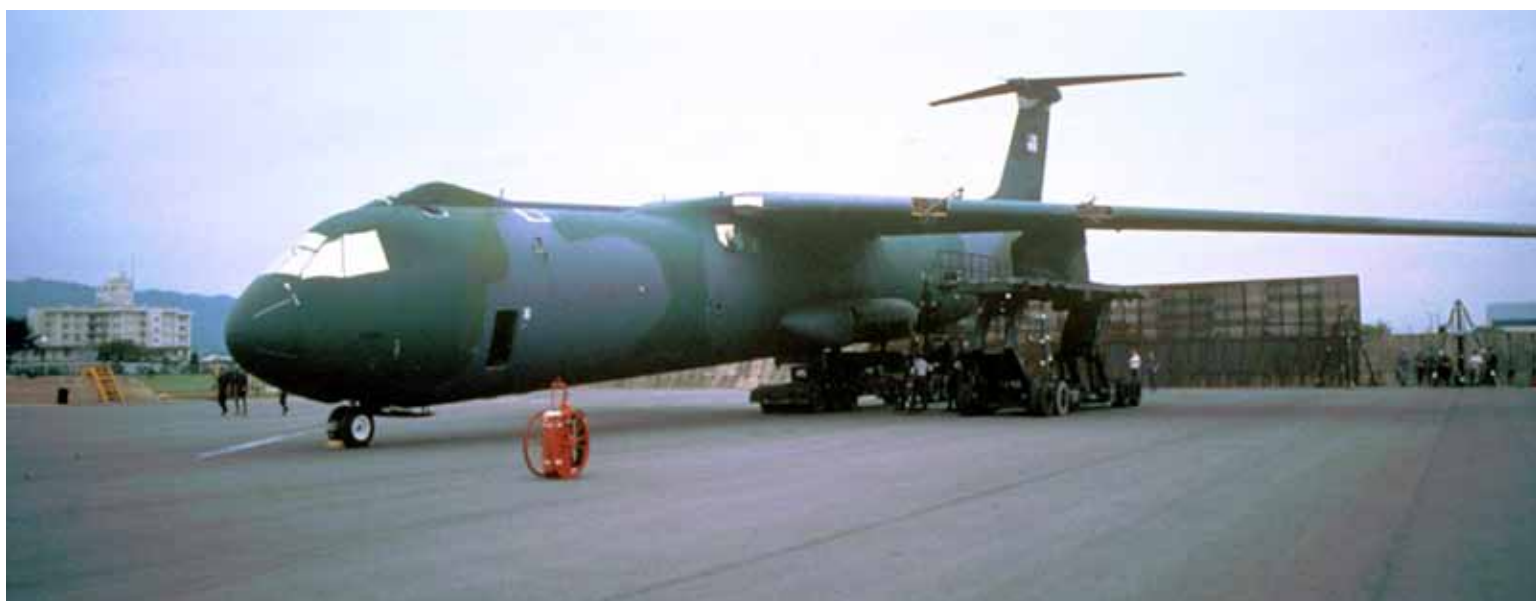
*67-0029 being moved from the accident scene to the parking ramp. (USAF photo from the Dave Grant collection)<sup>10</sup>*
