## Mortality in Army Aviation

A document of considerable historic interest was prepared on 28 February 1914 by the Office of the Chief Signal Officer, War Department, Washington, D. C. and has been made available to the JOURNAL through the efforts of Member, Robert F. Brooks. Prepared as a Memorandum for the Chief of Staff, its subject is Mortality in Army Aviation, and the document traces in detail the 11 fatal aviation accidents which had occurred since the initiation of Army aviation in 1908. Excluding a brief introduction, the full report is presented herewith.

### BRIEF DESCRIPTION OF ACCIDENTS AND PROBABLE CAUSES

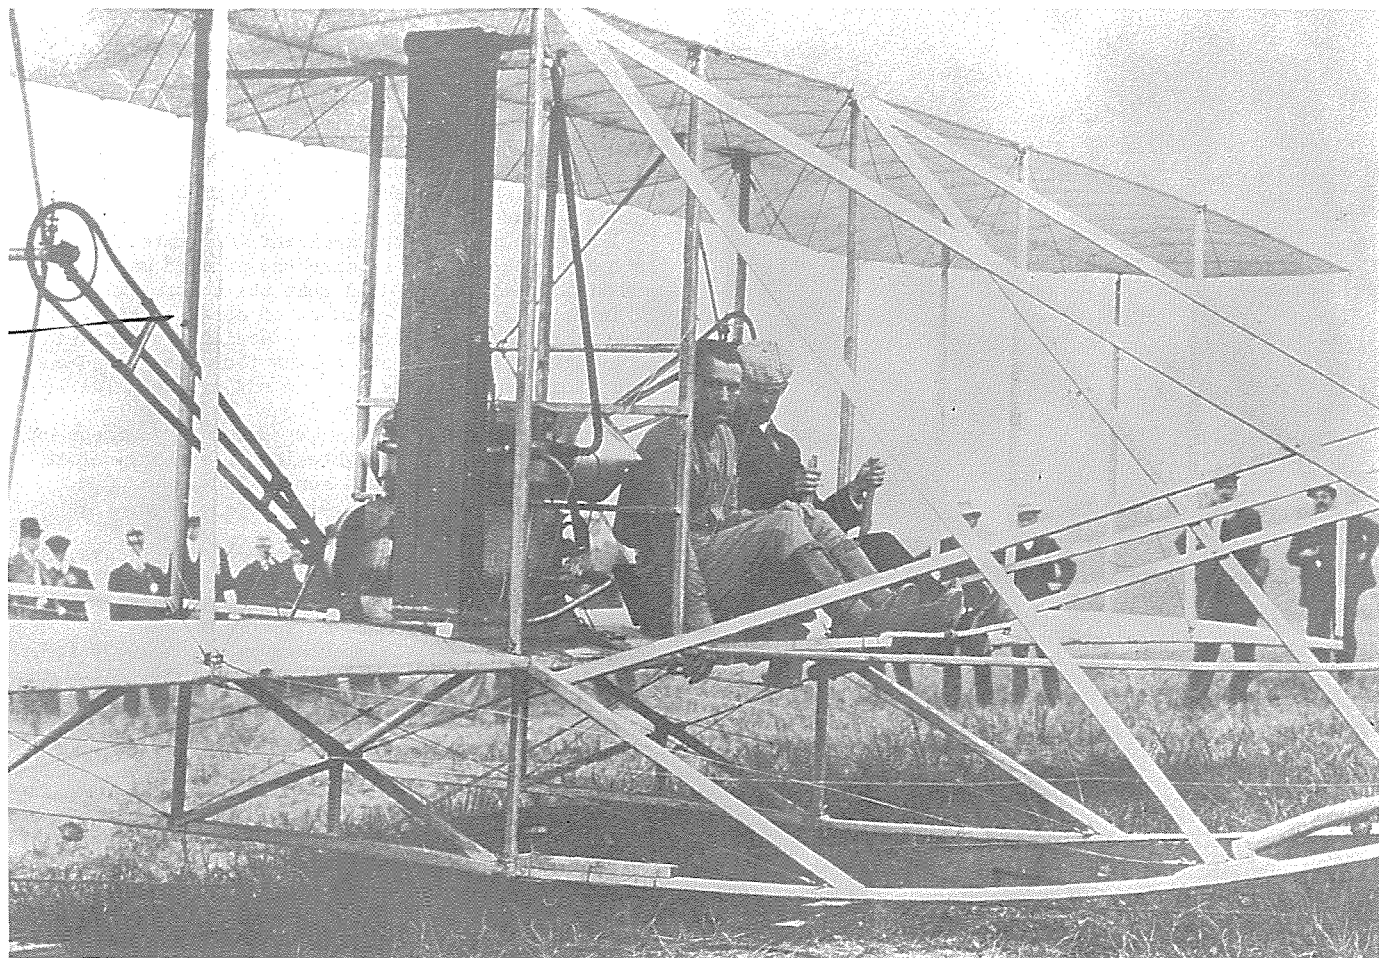
Lt. T. F. Selfridge (l.) and Orville Wright just before flight that resulted in first Army aviation fatality.

Mr. Orville Wright was flying the original Wright type of machine for acceptance test at Fort Myer, Va., with Lieut. T. F. Selfridge as passenger, on September 17, 1908, when one of the propellers broke, the machine being at that time about 75 feet from the ground. The machine side-slipped and nose-dived, striking the ground with such force as to fatally injure Lieut. Selfridge and break Mr. Wright's leg.

Cause of Accident: Breaking of propeller and consequent loss of lift in the machine. Lieut. Selfridge's

death can in no way be connected with any question of type of machine or skill of pilot.
