## TEETHING TROUBLES WITH F4B-1

By JESS C. BARROW

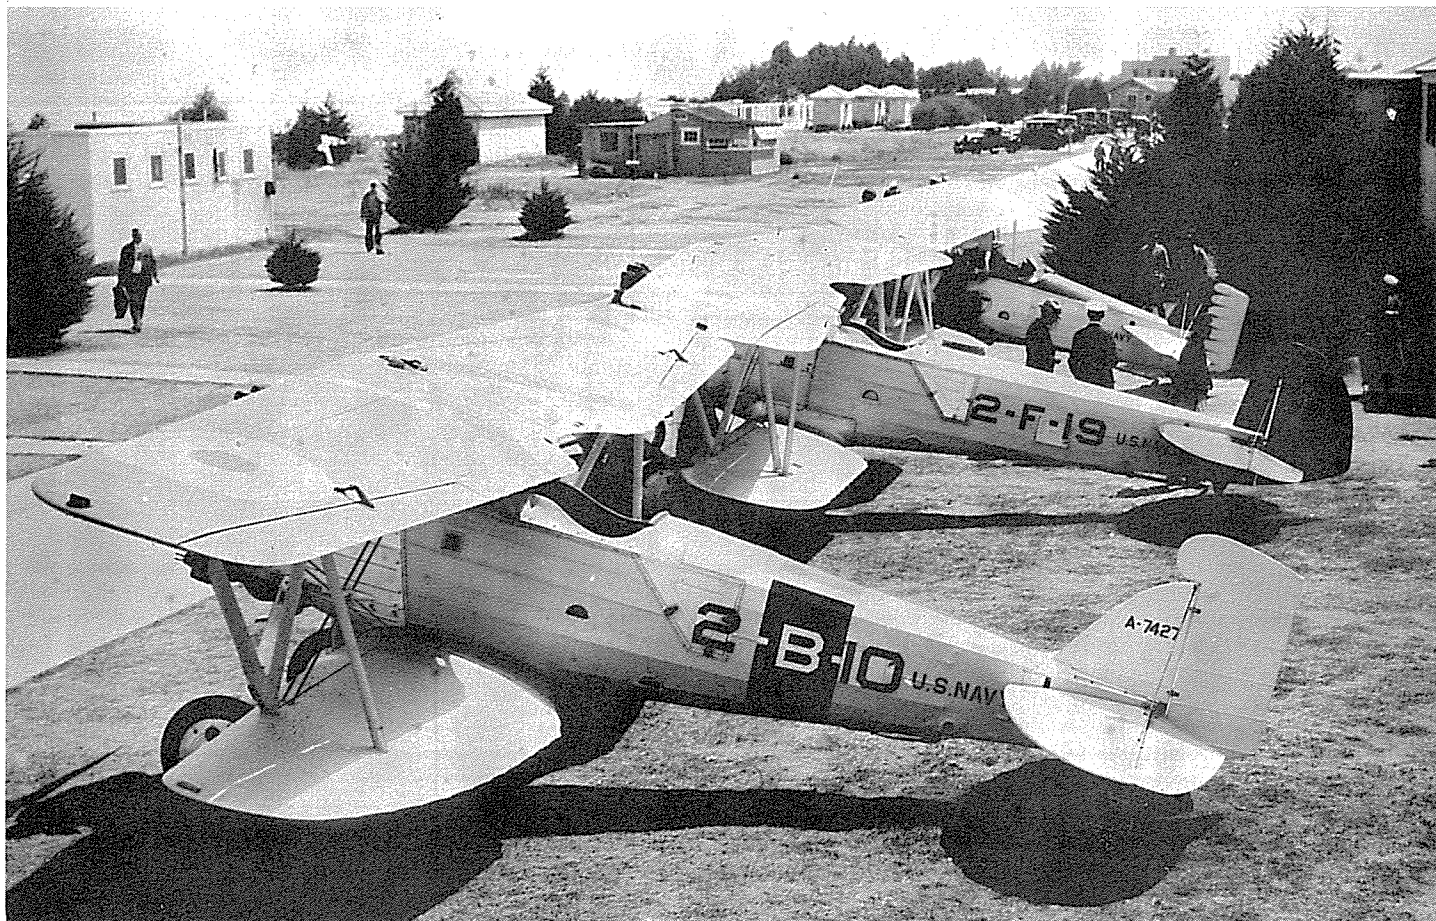
On 6 July 1928 the newly arrived Boeing Model 83 is lined up near the VF Squadron Office at North Island with two other Boeing veterans, F2B-1 and F3B-1, awaiting inspection by RAdm J.M. Reeves. Though not yet officially sold, "NAVY" shows on the fuselage. (Photo-Navy/Nat'l Archives)

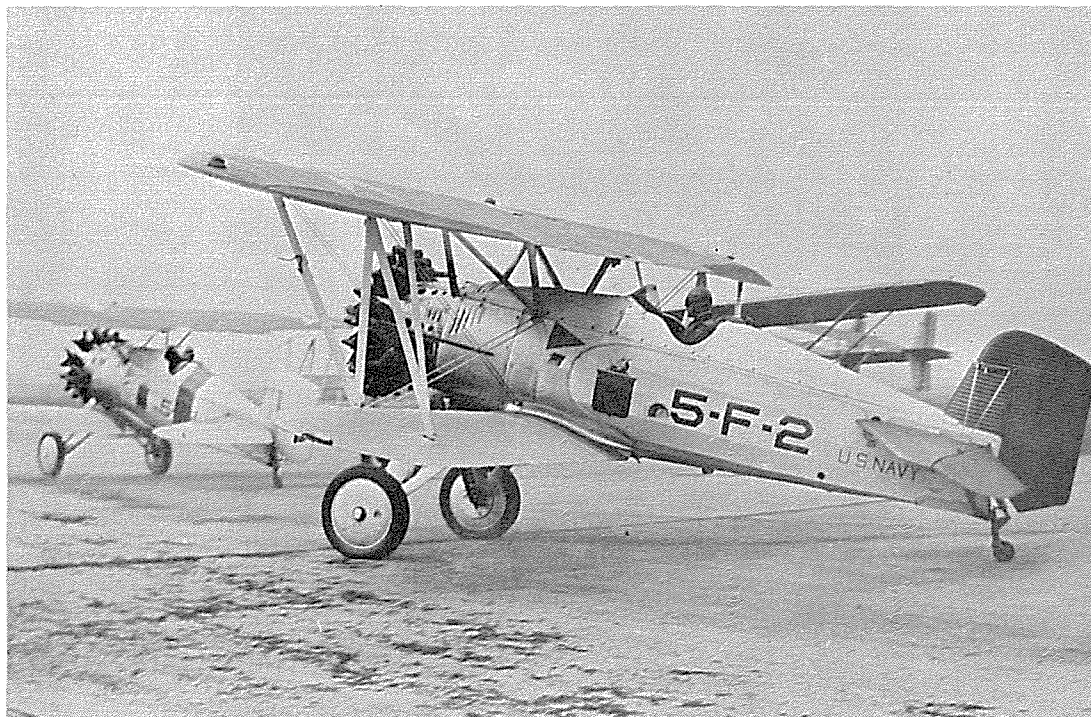
Fighting Squadron Five's Number 1 and 2 airplanes taxi out for takeoff (past familiar tail assembly of Sikorsky S-38, showing at rear, possibly the Navy's XRS-2). At this time the arrestor hooks had not been installed, but the Boeing designed tail wheels were in use. Engine cylinder fairings had long since been removed as cooler engine temperatures could be maintained without these. (Photo - Fred C. Dickey, Jr.)

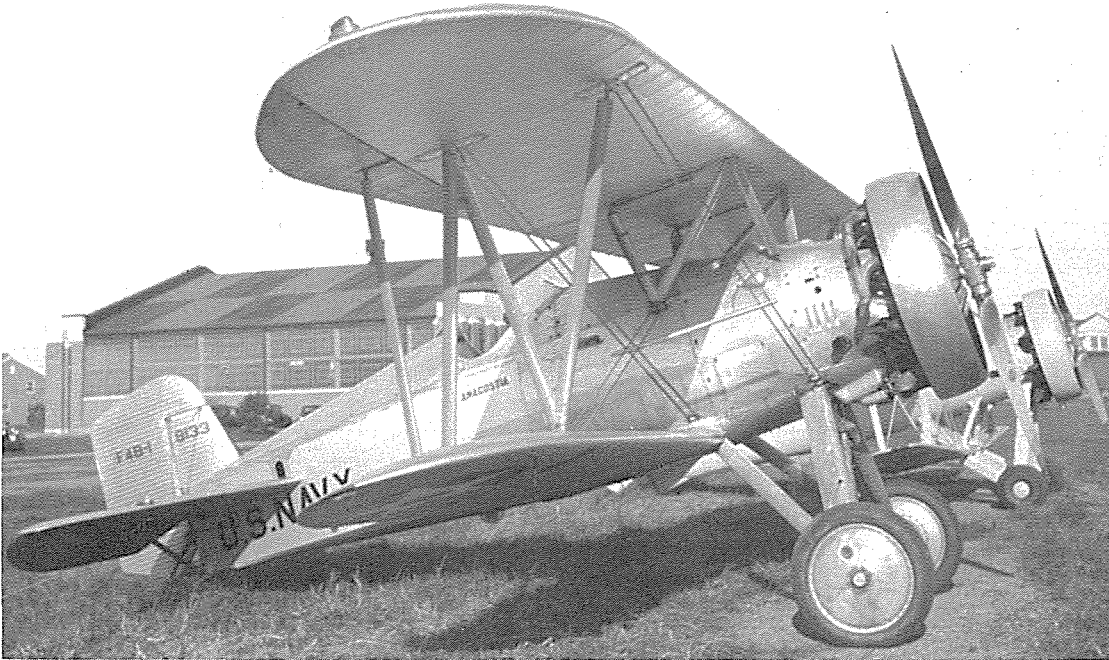
A-8133 was the first of the production F-4B-1's to be delivered, and went to Anacostia on 29 June 1929, there to become the personal airplane of Asst. Secretary of the Navy David S. Ingalls for a short time. It went back to the factory later and returned again to Anacostia in early 1930 where it was used as a test and utility airplane. Berliner-Joyce XFJ-2 in background.

| SERIAL NUMBER | DEL. DATE | SQUAD. ASSIGNMENT* | HOURS FLOWN** | DATE STRICKEN | DISPOSITION AND REMARKS |
|---|---|---|---|---|---|
| A-8133 | 6-24-29 | Anacostia | 792 | 7-31-34 | Worn out. Personal airplane of Asst. Secy/Navy Ingalls. |
